Appendix 1- Elementary School Audit Reports

Houghton Elementary Walking Audit

Route 1: South on Military Rd., North on Dodge St.

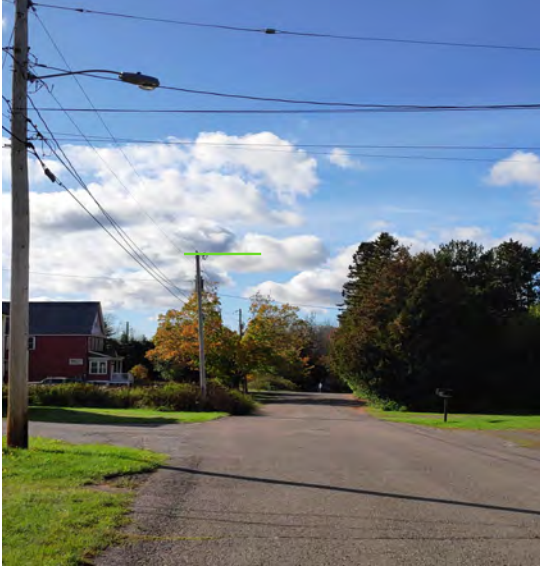
Frue Ave, facing west

Steep declining slope leads to intersection with Military road. Shrubbery forces pedestrians to walk in road at points.

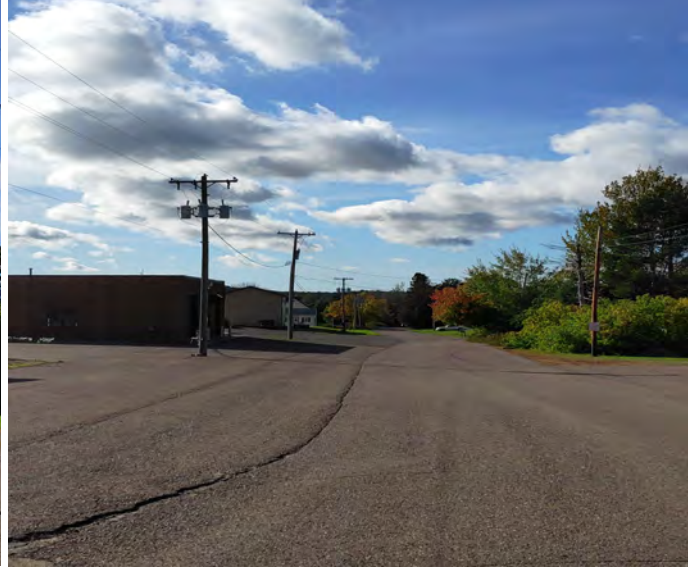
Long stretch of no sidewalk. Few streetlights. Large portion of road is connected with busy parking lot on the left.

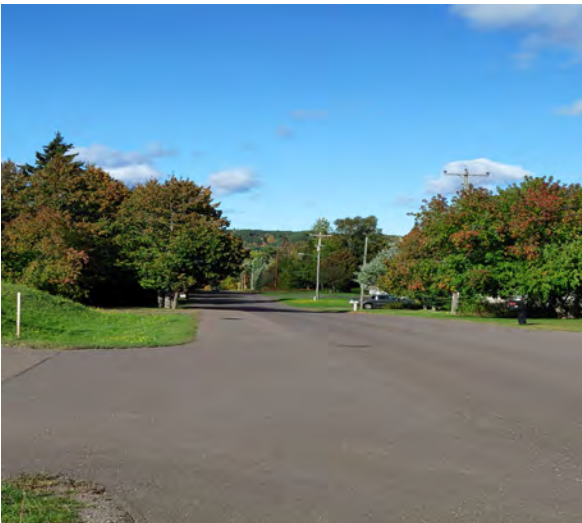
Dodge St, facing north

Sidewalk on the left side is hardly distinguishable from the road. Cars speed on this road. Fair amount of school children walk through here.

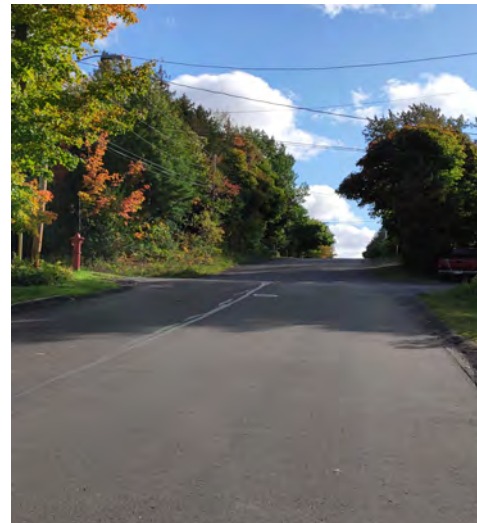
Dodge St, facing south

This road has several sharp declining slopes, rendering oncoming traffic difficult to see. Sidewalk has ended, leaving no designated walking spaces.

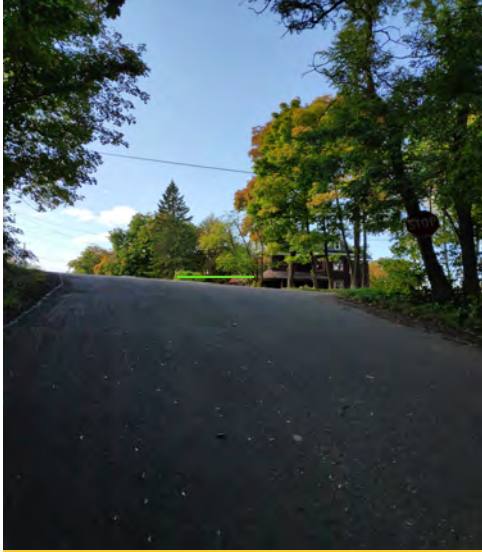
East Douglass Ave, facing west

Sharp incline in road right before an intersection. No sidewalks or designated walking areas. Stop sign is fixed to tree on the right.

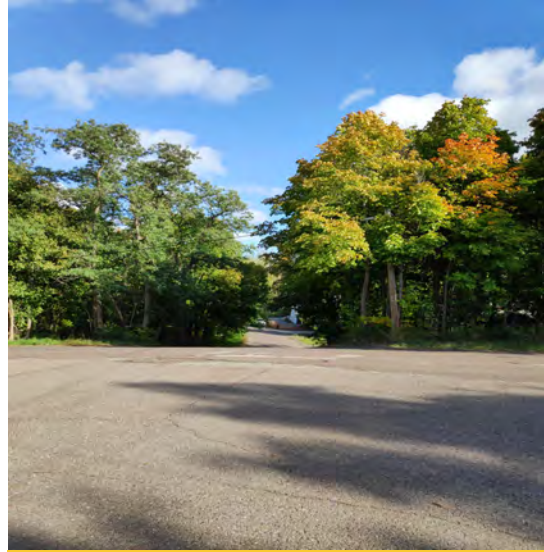
East Douglass Ave, facing east

No crosswalks, sidewalks or street lights. Poor visibility with oncoming traffic due to plateaued intersection.

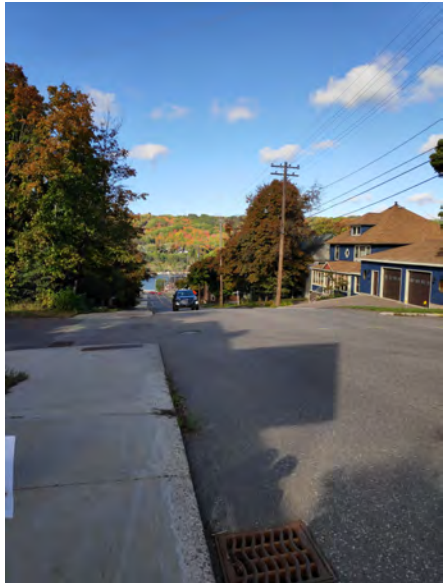
Bridge St, facing north

Only left side of the road has sidewalk. Cars speed. Not many street lights.

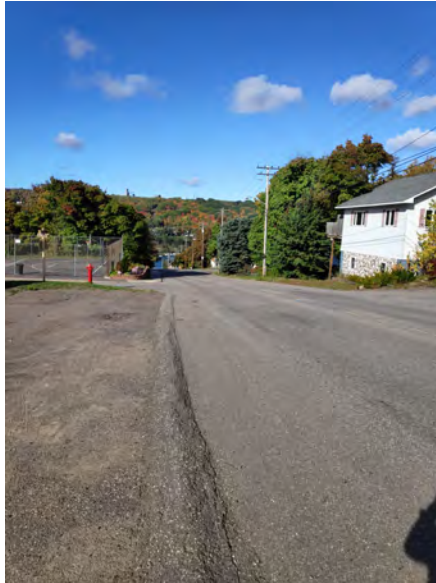
Sidewalk ends. Heavy and fast traffic during school drop-off/pick-up. Few street lights.

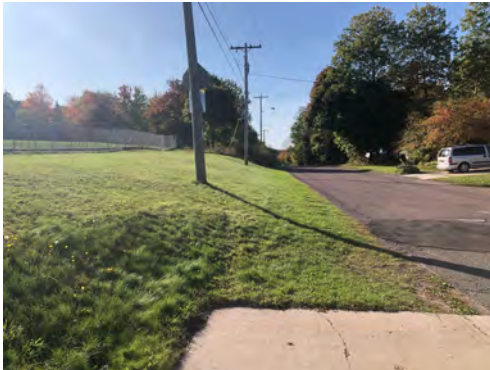
Jacker Ave, facing west

Sidewalk ends on school grounds. No sidewalk on north side of Jacker Ave in the School Zone.

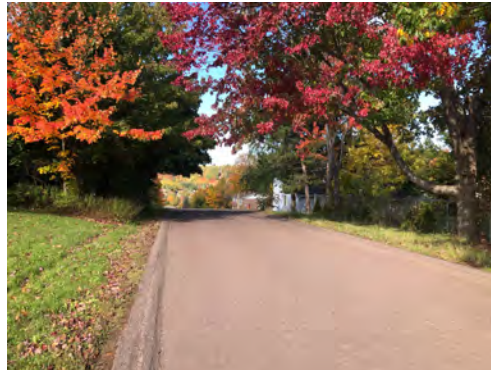
No sidewalk on either side of Jacker Ave and hill obstructs driver's view in the School Zone.

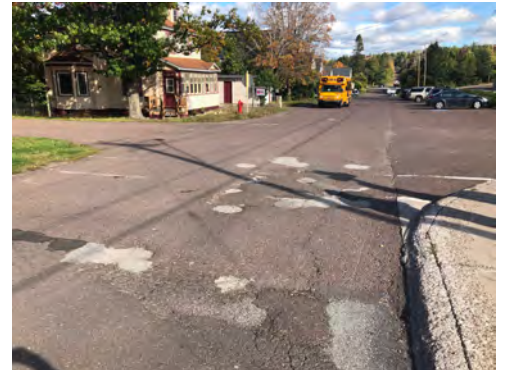
Jacker Ave, facing east

Poorly marked crosswalk and no sidewalks on north side of Jacker Ave in the School Zone.

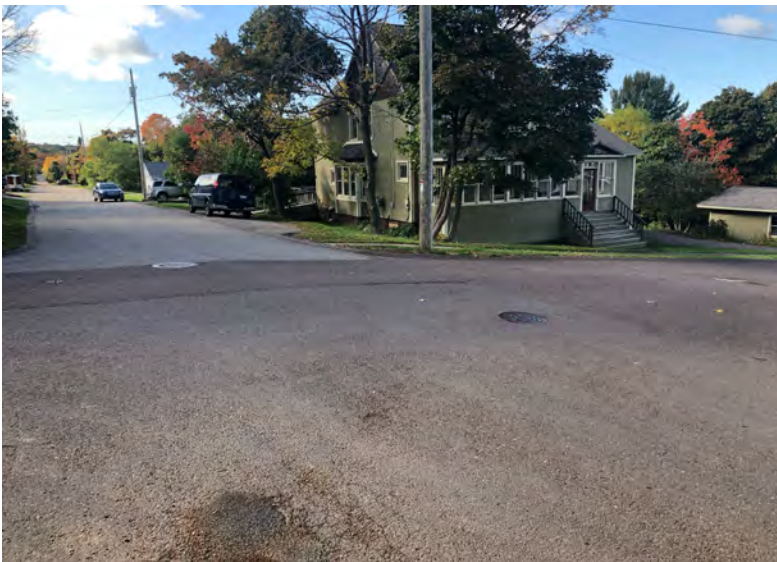
Calverley Ave & 4th St, facing north

No crosswalks or sidewalks at this intersection. Vehicles do not obey speed limits nor do they have stop signs on 4th St.

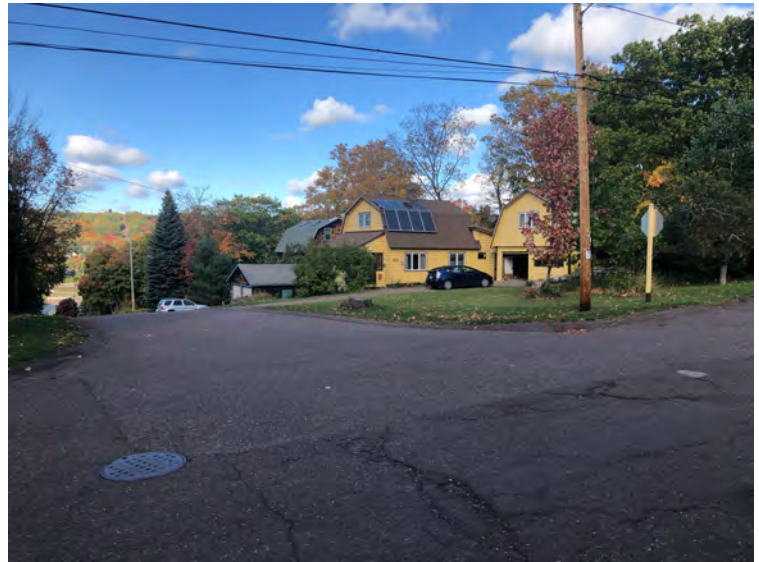
Calverley Ave & 2nd St, facing north

Vehicles do not obey speed limits at this intersection. Steep hill obstructs driver's view driving south. No sidewalks or crosswalks at this intersection.

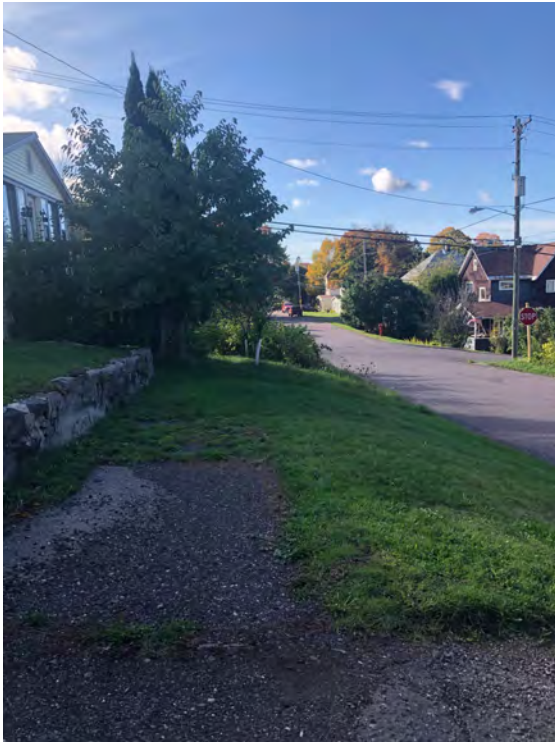
Edwards Ave, facing west

Sidewalk along the south side of Edwards Ave abruptly ends 90 feet before reaching the intersection with 6th St. This sidewalk is poorly maintained. There is no sidewalk on the north side of Edwards Ave nor the street segment west of 6th St.

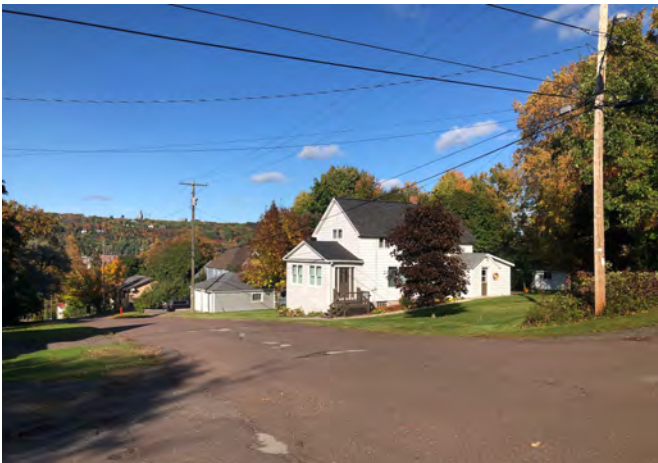
6th St & Baraga Ave, facing northeast

No crosswalks or sidewalks at this intersection and vehicles drive too fast down hills.

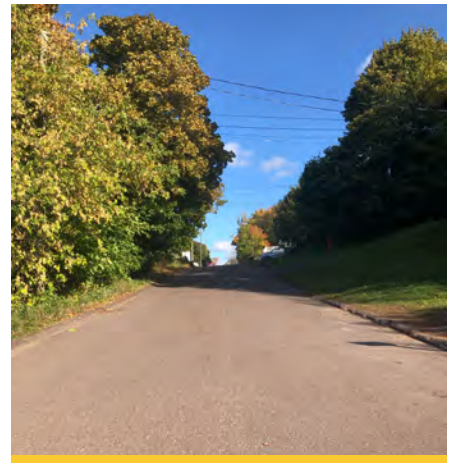
6th St & Calverley Ave, facing south

No vehicle stop signs, no sidewalks or crosswalks, and hill obstructs driver's view at this intersection.

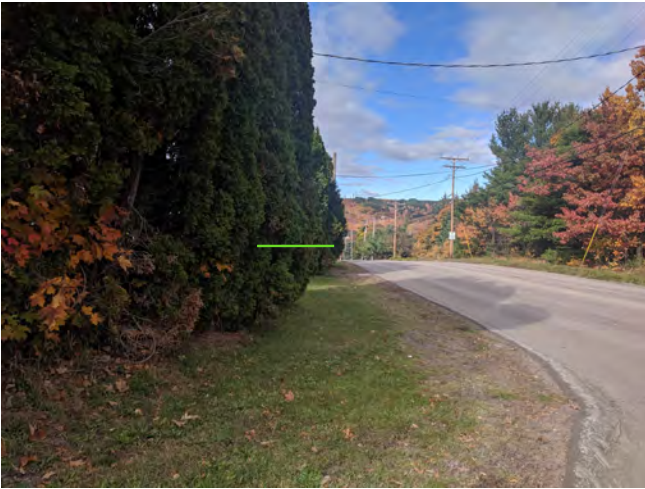
Bridge Street, facing north

Lack of sidewalk on either side of road. Fast traffic. Poorly lit. Trees limiting visibility of drivers and pedestrians.

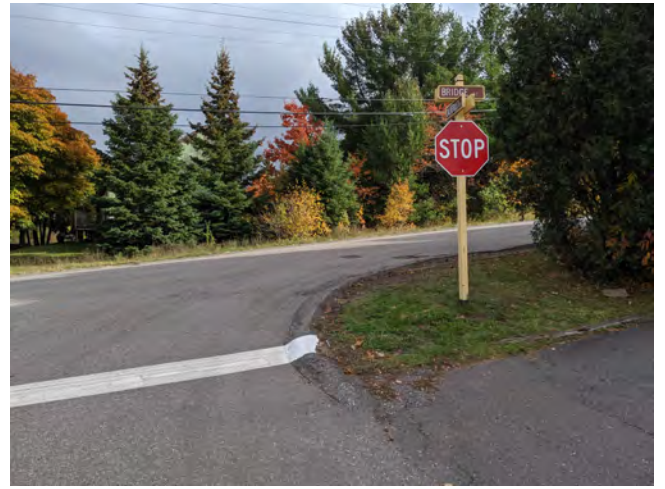
Baraga Avenue, facing east

Trees blocking visibility around corner from both directions. No crosswalk across Baraga Avenue. No sidewalk on Bridge Street.

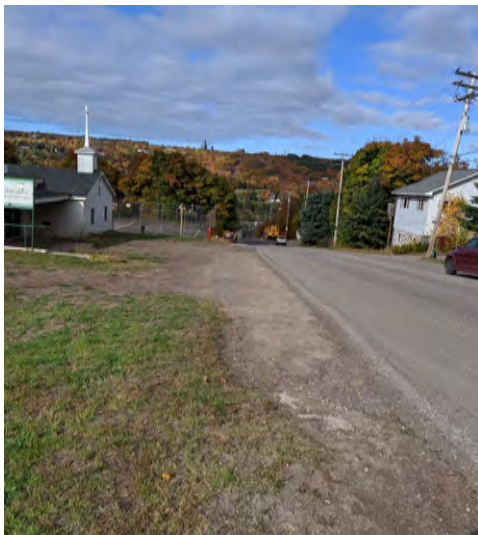
Bridge Street, facing north

Lack of sidewalk on either side of road. Fast traffic. Poorly lit.

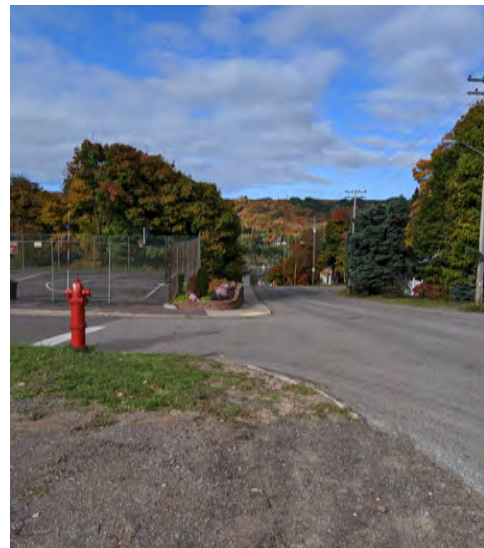
Bridge Street, facing north

No crosswalk across Edwards Street.

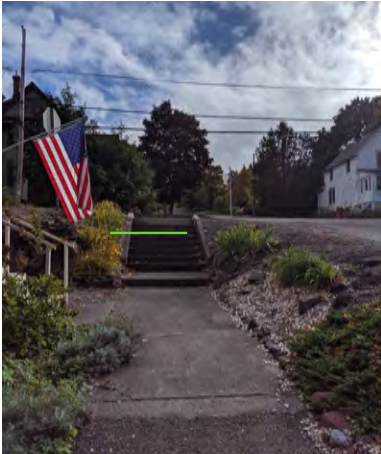
Second Street at Douglass Street

Steep stairs leading to crossing Douglass Street. No crosswalk across Douglass Street. Limited visibility.

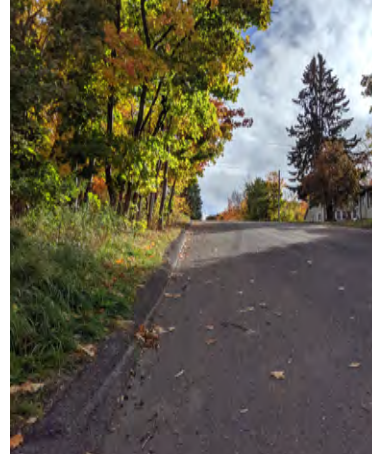
Second Street, facing south

Road narrows after Douglass Street crossing. No sidewalks. Limited visibility up due to steepness of hill.

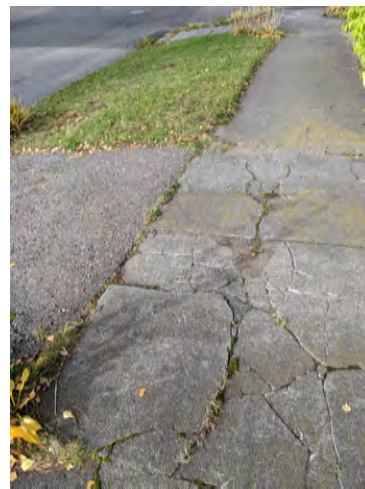
Second Street, facing east

Degradation of existing sidewalk infrastructure.

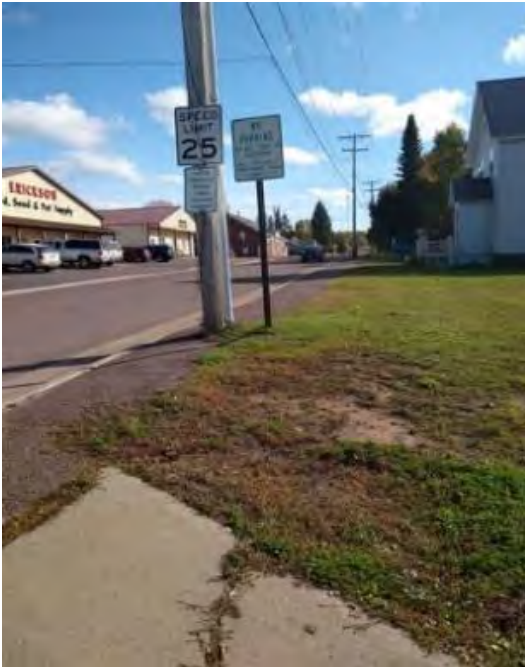
Military Road, facing south

Street is too narrow and there is little distinction between the road and the sidewalk. Cars have low visibility when turning.

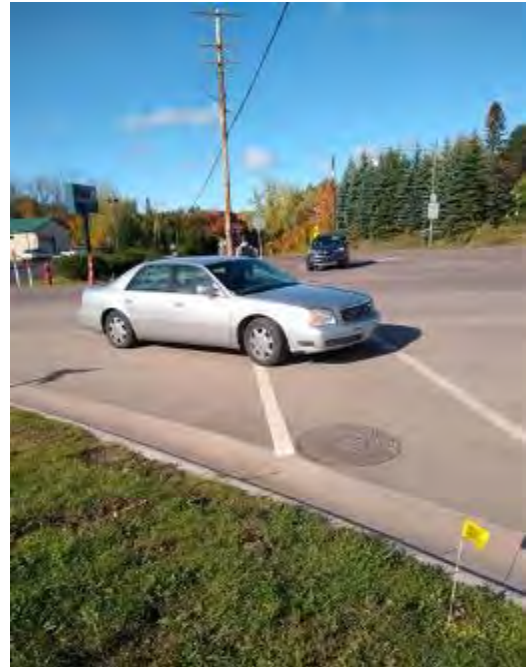
Sharon Ave, facing north

Cars creep up on pedestrians and do not yield.

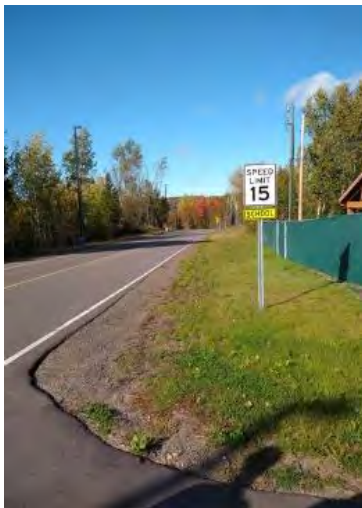
Schoolhouse Road, facing north

No sidewalk is present. When sidewalk is present, only one side is available.

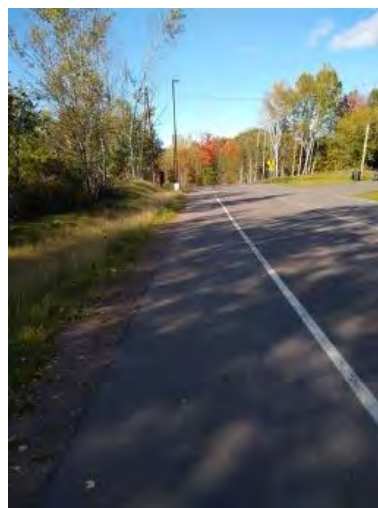
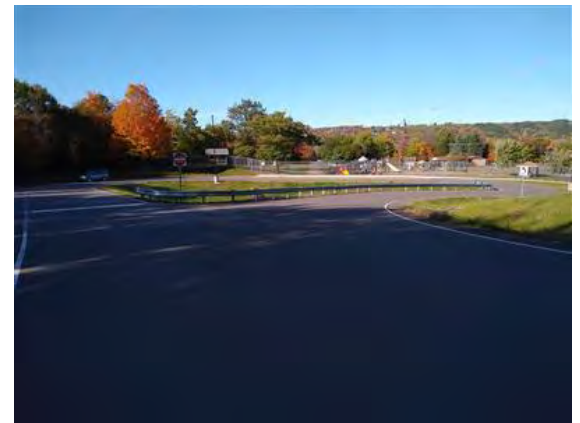
Shortcut through parking lot maybe dangerous as there is no painted crosswalk.

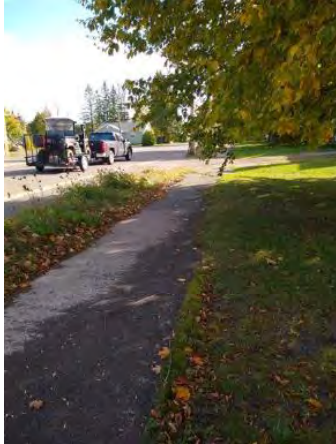
Superior Street, facing south

Sidewalk is too narrow and is sometimes blocked or cluttered

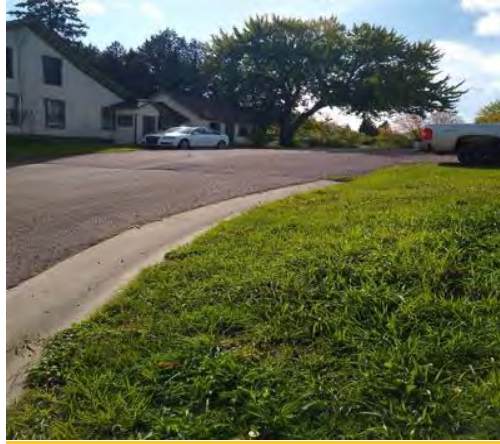
Driver's view is obstructed with such a wide curve. Additionally no sidewalk is present.

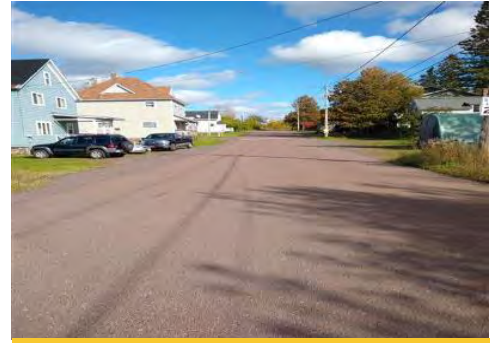
Superior Street, facing east

Street is wide but lacks sidewalk or trail.

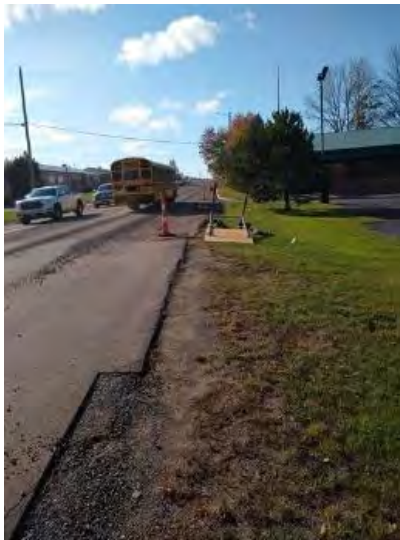
Sharon Ave, facing west

No sidewalk and path is too narrow

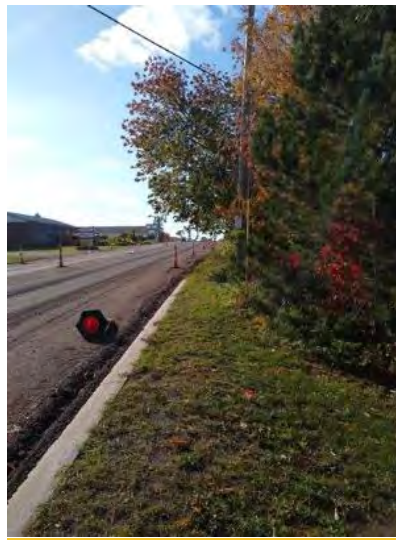
No warning for school zone, or for speed limit. Existing Signs are damaged or down.

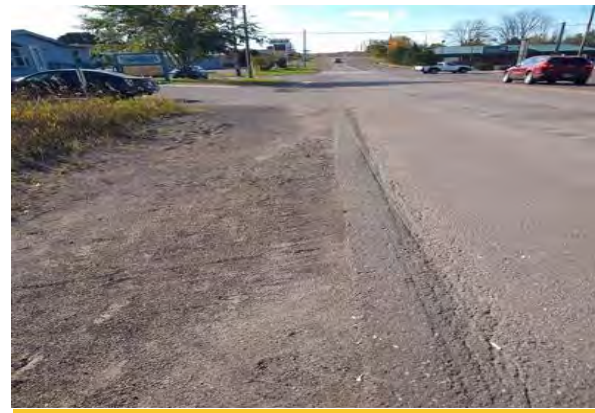
Unpaved shoulders. Too close to the oncoming traffic.

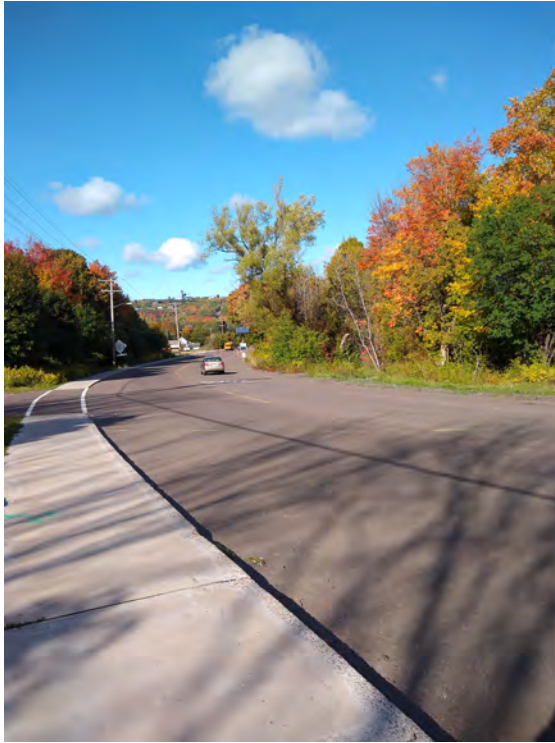
Bridge St. facing north

Fast, loud, and busy traffic. No signals and pedestrian crosswalk is not maintained. Large barrier for students when traveling to and from school.

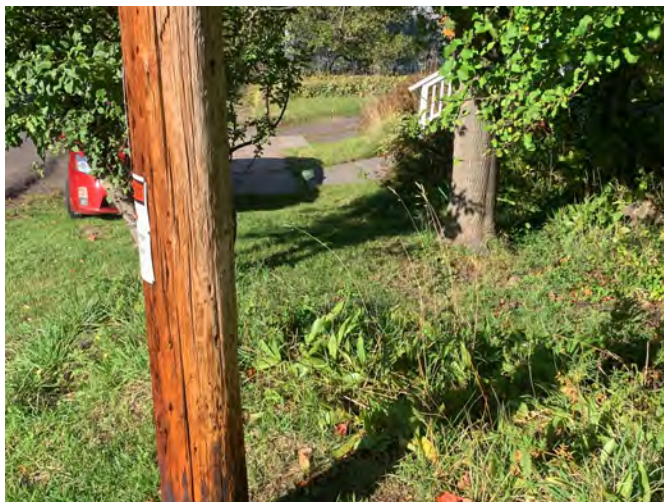
Dodge St. facing north

Sidewalk only on one side of the street and abruptly ends before reaching the intersection of Dodge St. and 7th Ave. Path continued on grass is obstructed by a light pole and trees.

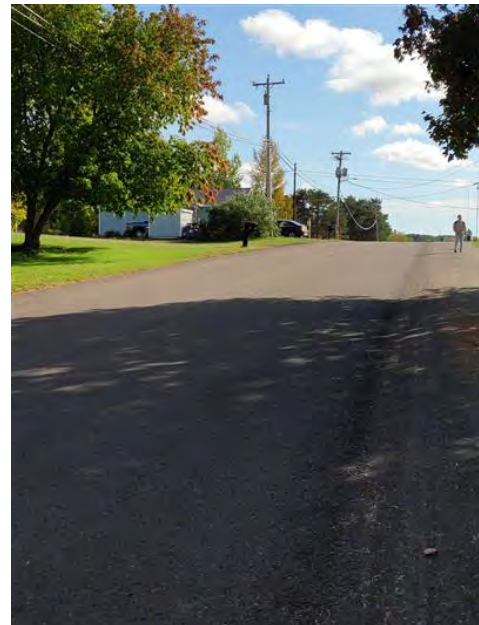
Dodge St. facing south

Dodge St. and 7th Ave. intersection is dangerous. Fast traffic and obstructed pedestrian view make it difficult to cross.

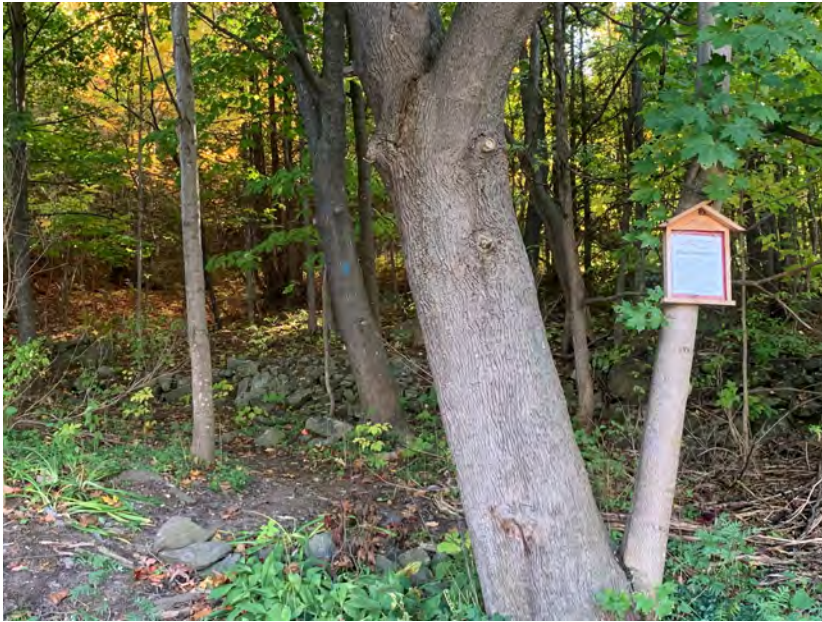
E South St. facing south

Owned by Keweenaw Land Trust. Trail is not well marked with poorly established paths. Unknown winter maintenance and snow clearance. Walk through wooded area is enjoyable and shortens travel time. Would be a good transport route if concerns are addressed.

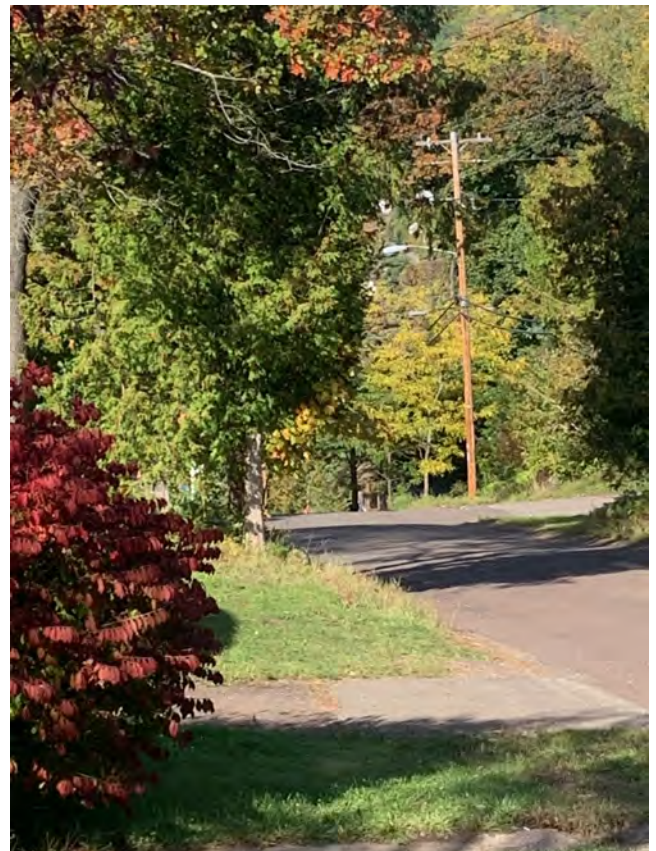
Agate St. facing north

Driver and pedestrian views are obstructed due to steep slope. Fast traffic and high volume of pedestrians and vehicles. No sidewalks or safe pedestrian crossings present. Large snowbanks narrow the street in the winter, leaving little room for pedestrians to walk safely on the side.
