# Houghton Middle School Walking Audit

### Route 1: Dodge St. to West Houghton

### Route 2: Hurontown - Neighborhood West of Houghton Middle School

### Route 3: Agate Street Neighborhood

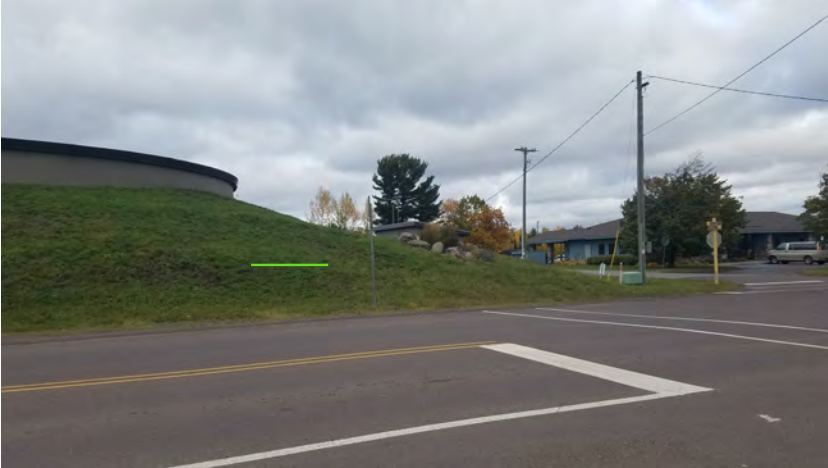
### Gundlach Rd. facing north

No sidewalk, only a paved shoulder that is not well-maintained. Traffic does not yield to pedestrians. Crosswalks do not lead to sidewalks. Traffic signal is only a flashing right light. Can take a while for pedestrians to cross.

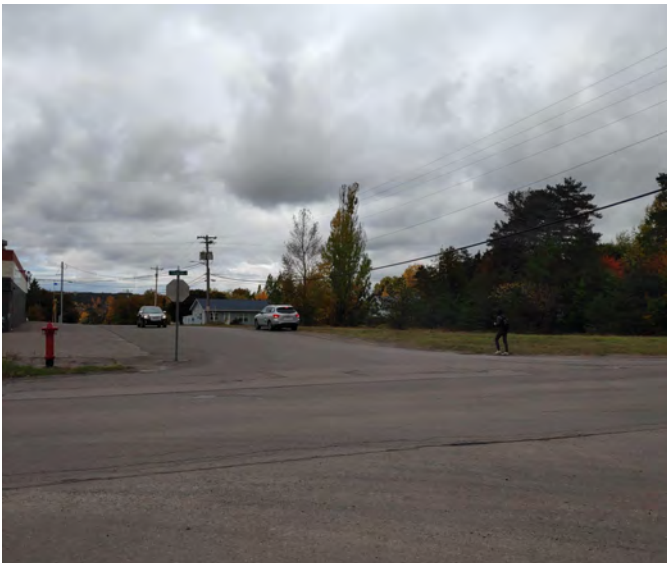
### Dodge St. facing north

No crosswalk. No clear place for pedestrians to wait on the side of the road. No pedestrian signal. Traffic does not yield to pedestrians.

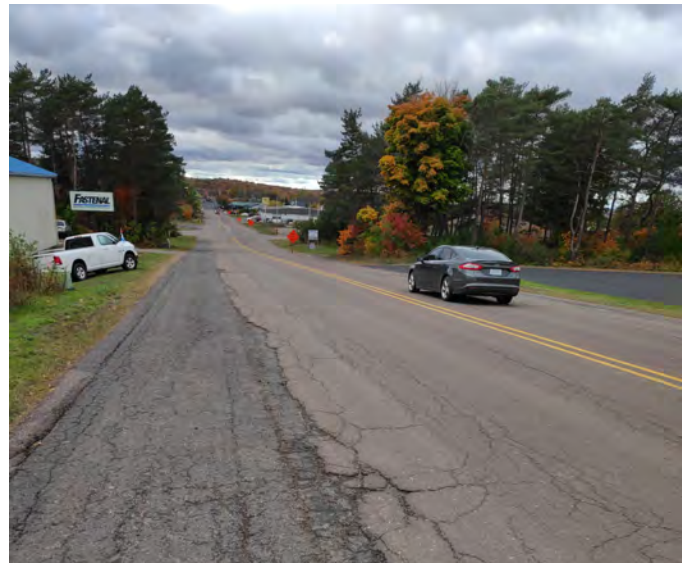
### Sharon St. facing intersection with Dodge St.

Paved shoulder is wide but not well-maintained. No curb between traffic and pedestrians. Traffic is fast near pedestrians.

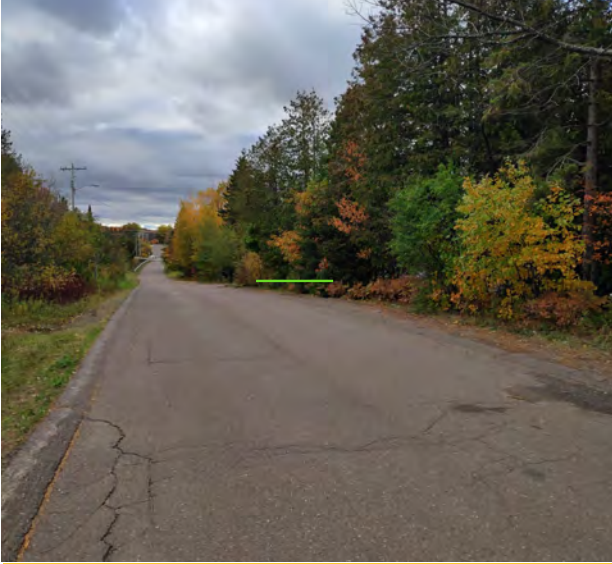
**Jacker Ave. facing west**

No sidewalks. Road is narrow and not well-maintained. Plants force pedestrians to walk on the road. Road is not well lit.

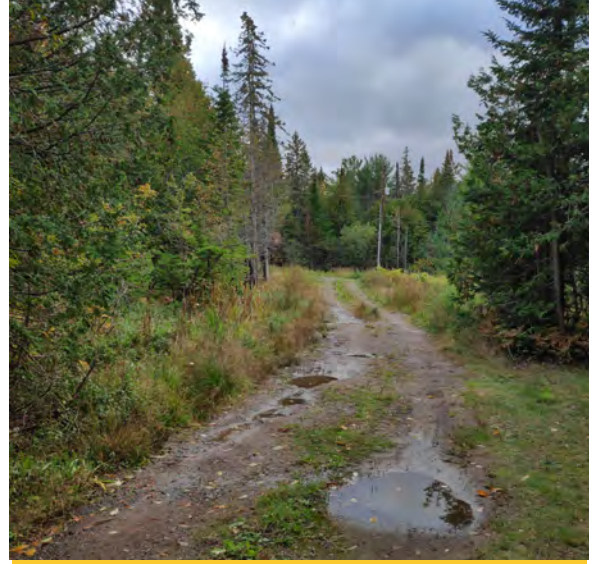
**Shortcut between Jacker Ave. and Baraga Ave.**

Rough two-track through woods. Potential shortcut for students. Property rights unclear.

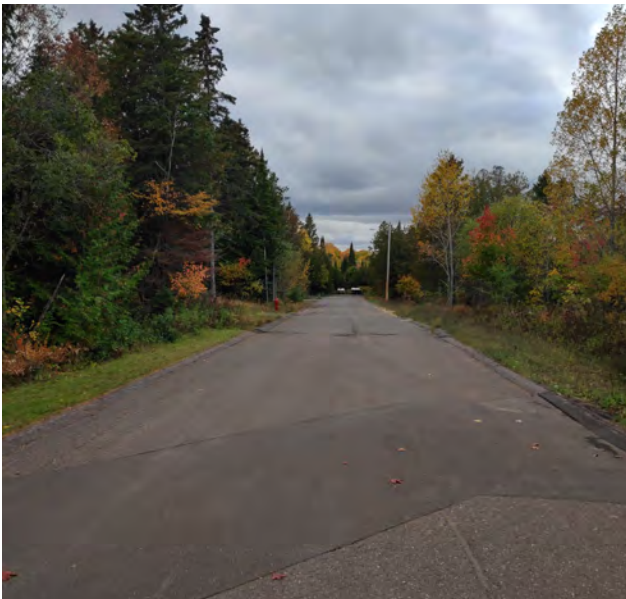
**Baraga Ave. facing east**

No sidewalks. Street is narrow and not well lit. Little traffic on this street.

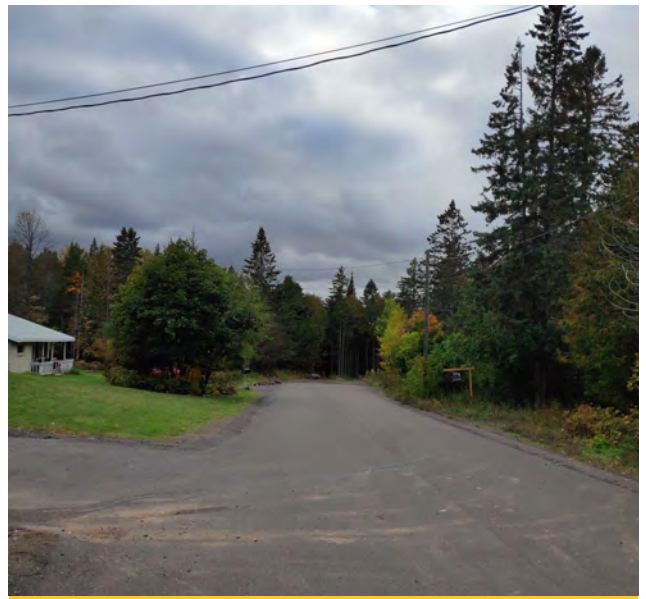
**Sibley Ave. facing west**

No sidewalk. Street is not well lit. Little traffic on this street.

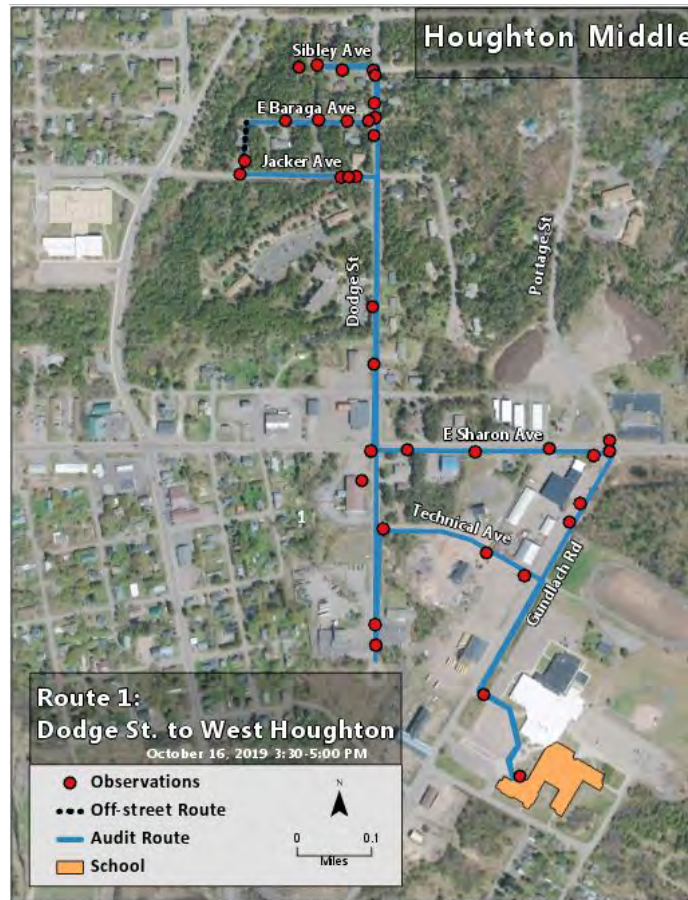
Route 1: Dodge St. and Jacker Ave.

Map of all observations

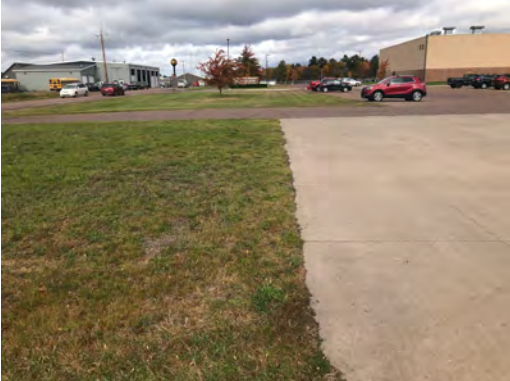
Gundlach Rd, facing south

This sidewalk ends in the School Zone before reaching Gundlach Rd. The area receives a high volume of foot-traffic and vehicle traffic.

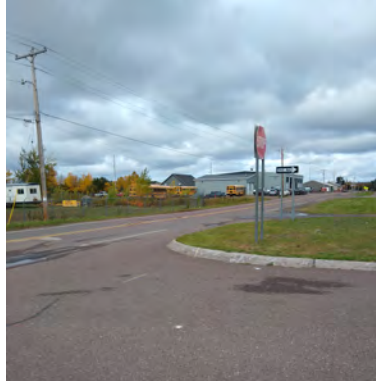
Gundlach Rd & B F Gaffney Dr, facing northwest

No sidewalks or crosswalks in the School Zone and most traffic does not obey speed limits.

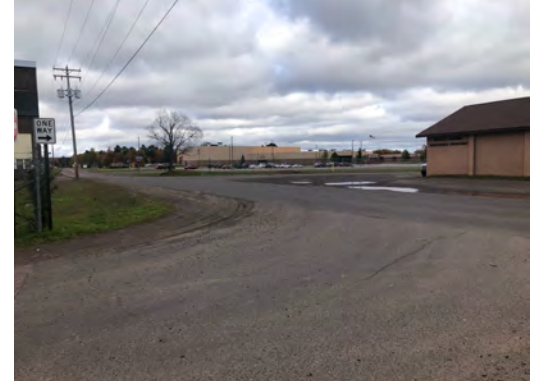
Frederick St & Gundlach Rd, facing northeast

Poor lighting and no sidewalks or crosswalks in the School Zone makes this intersection dangerous for student pedestrians.

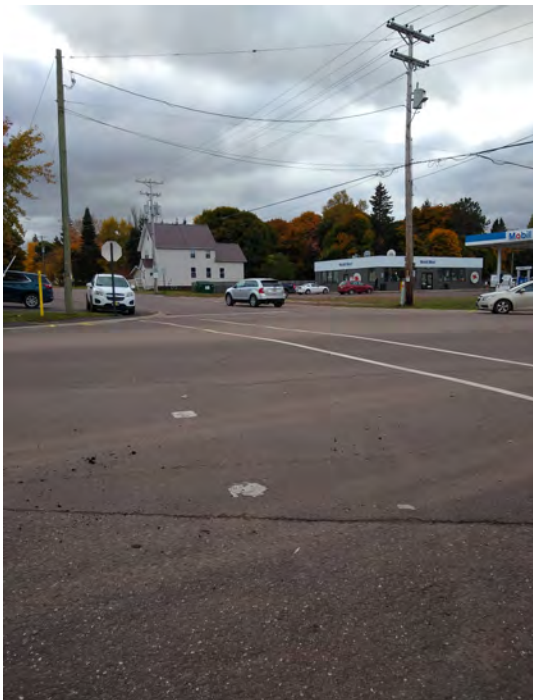
Superior Rd & E. Sharon Ave, facing northeast

Poor or no sidewalks, high traffic volume, and no vehicle or pedestrian signals to cross Sharon Ave.

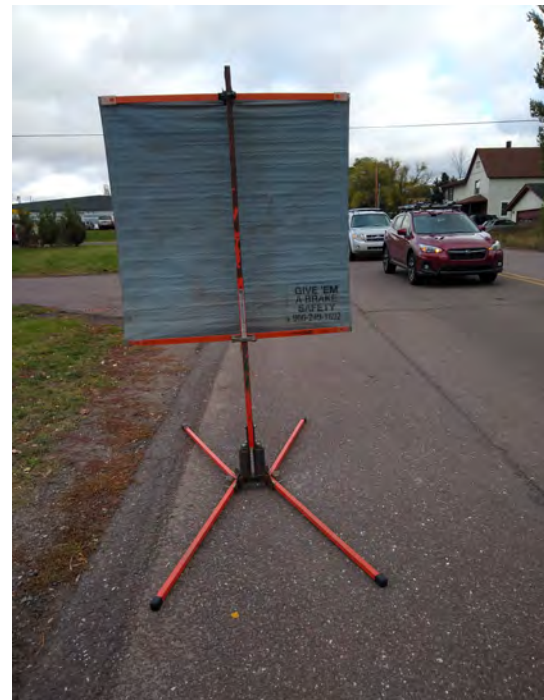
E. Sharon Ave, facing east

Along Sharon Ave, there are no sidewalks and a high volume of fast-moving traffic, making this a dangerous road for pedestrians.

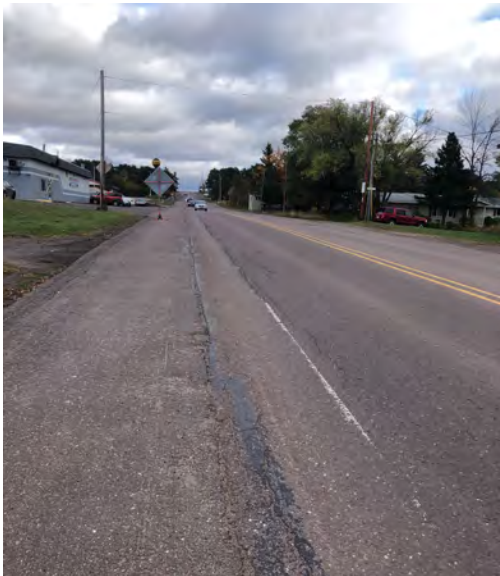
E. Sharon Ave, facing east

No sidewalks along Sharon Ave, students feel unsafe crossing at intersections with no signal.

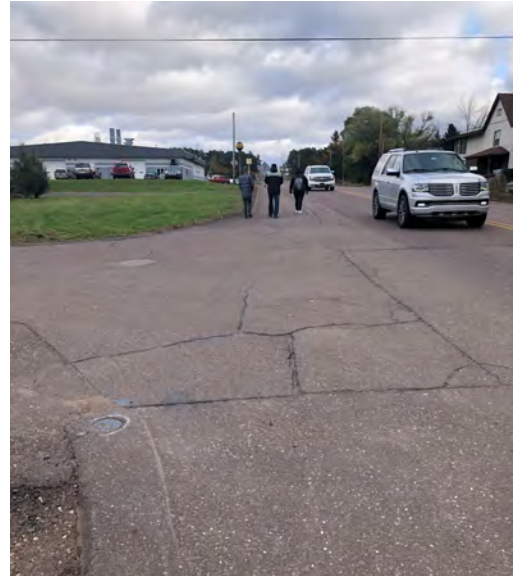
E. Sharon Ave & Dodge St, facing east

No crosswalk across Dodge St and no sidewalk along Sharon Ave. It feels like an unsafe place to walk.

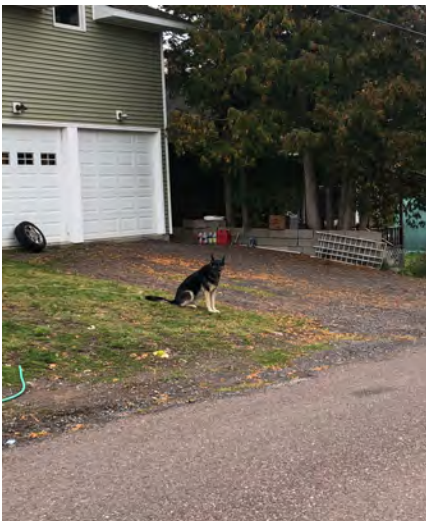
Frederick St, facing southwest

A large, aggressive-looking dog could scare potential student pedestrians from using this street.

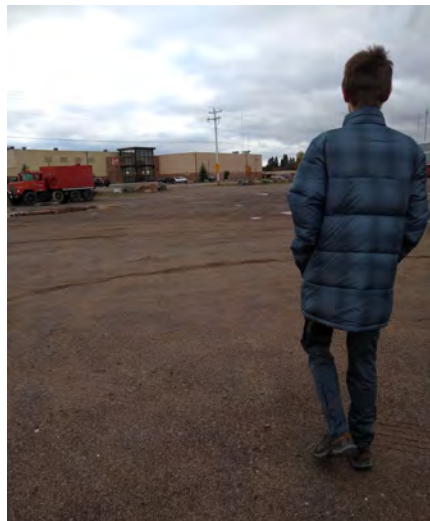
Technical Ave & Gundlach Rd, facing southeast

A short-cut through an industrial parking lot across the from the Middle School.

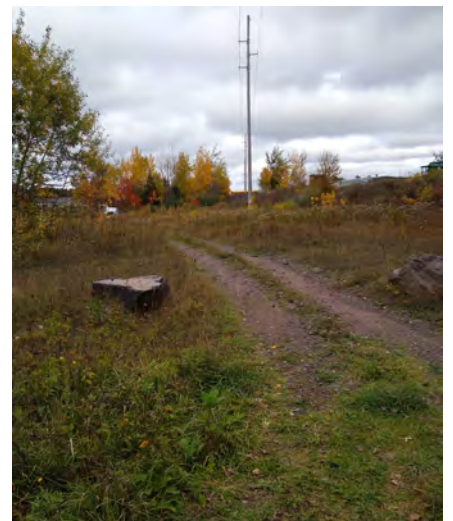
Frederick St, facing north

An informal trail that allows pedestrians to bypass Frederick St. into Hurontown.

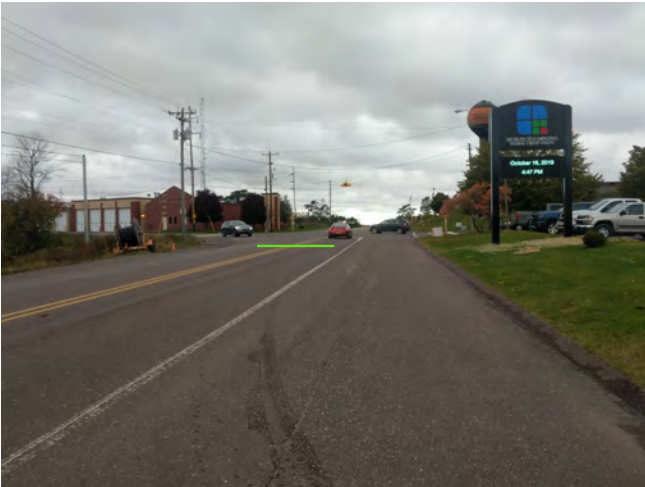
Sharon Drive, facing west

Poorly labeled bike lane. Hazardous amounts of high speed traffic. Poor lighting.

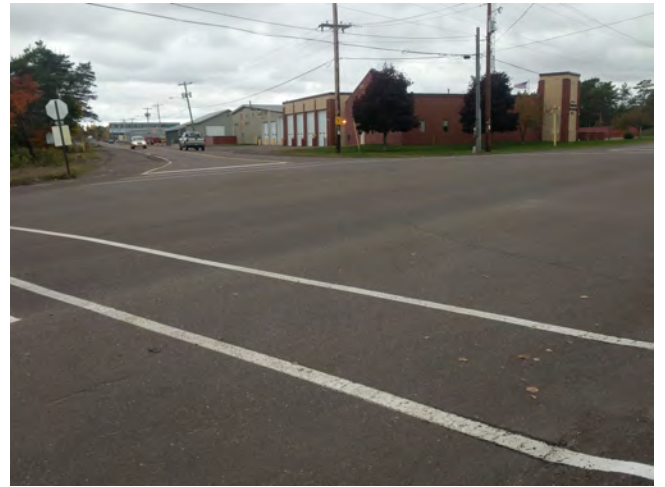
Gundlach Road, facing south

Cars not yielding to pedestrians. Hazardous amounts of traffic at four-way stop.

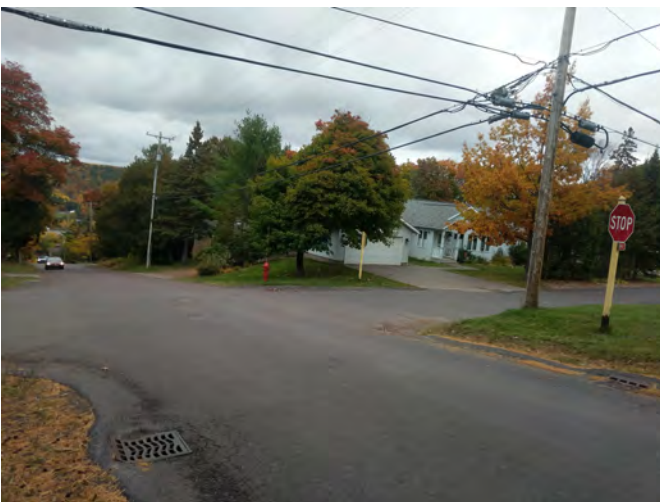
Agate Street, facing north

Lack of crosswalks to cross Agate or the east/west streets. Poorly lit. No sidewalks from 6th Street heading south. Lacking sidewalks on both sides of the road.

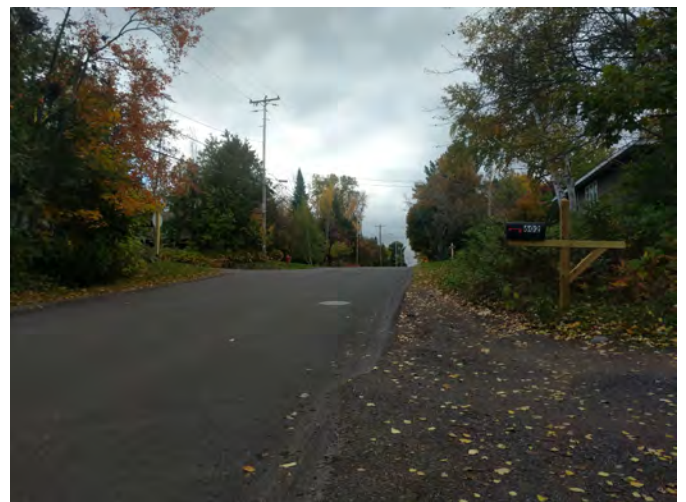
Agate Street, facing south

Narrow roads with limited shoulder space for pedestrians to walk. Steep hill. Limited visibility looking south.

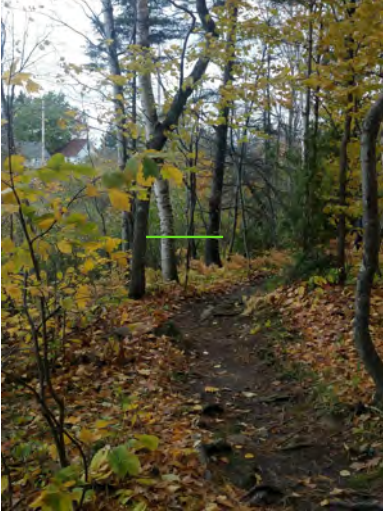
Along the School Trail

No lighting. Unofficial route that is unable to be passed during the winter months.

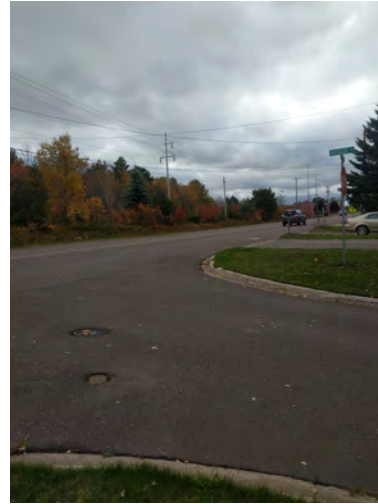
Crossing of Sharon Avenue to Datolite St

No marked crossing from the trail. Poorly lit. Hill obstructs view. No signal.

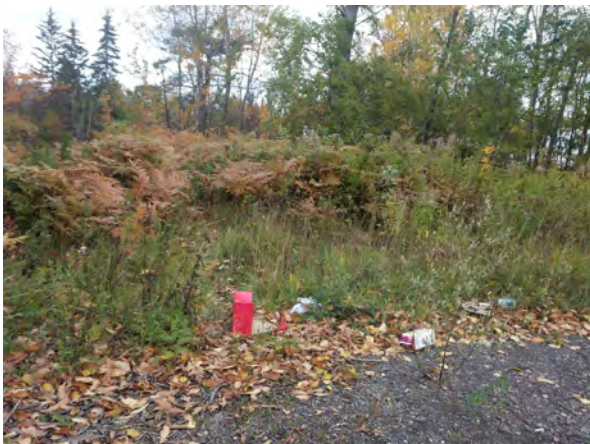
Entrance off Baltic Street

Not clearly marked. Significant amounts of litter. No lighting. Unable to be passed during the winter months.

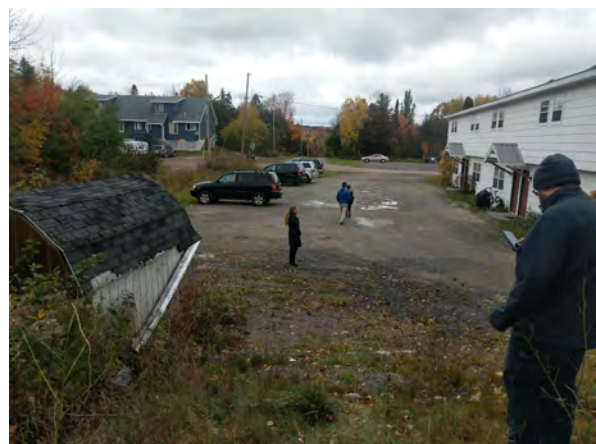
Exit onto 11th Avenue Parking Lot

Not clearly marked. No lighting. High volume of pedestrian traffic.

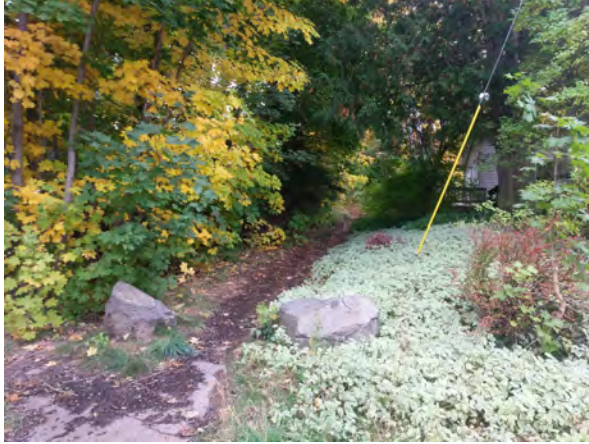
### 6th Street, facing north

Not clearly marked. No lighting. Well-traveled in the winter, but it not cleared.

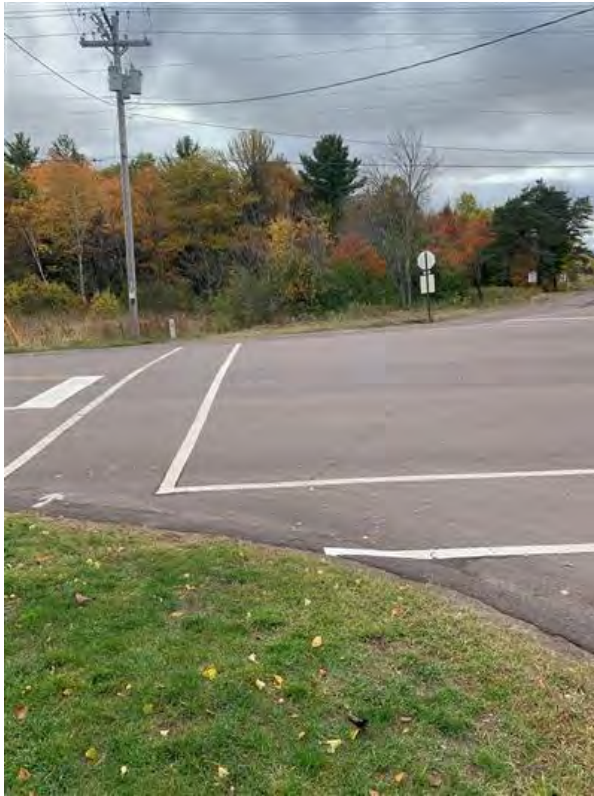
Sharon Ave. facing south

No pedestrian signals to indicate when to cross the street. Area of high pedestrian and vehicular traffic before and after school. Right-of-way confusion between drivers and pedestrians.

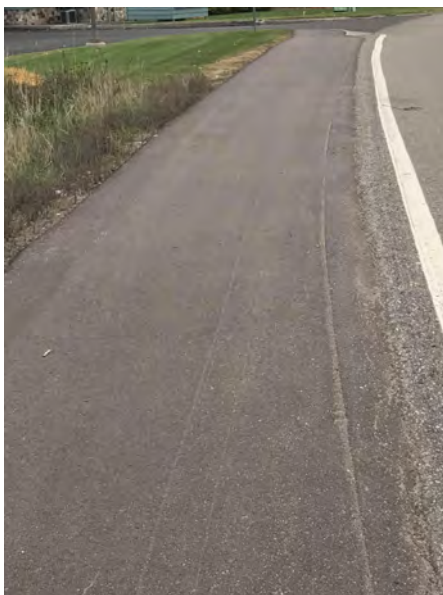
Portage St. facing south

Paved shoulder without curb is not continuous and only on one side of the street. Low traffic volume.

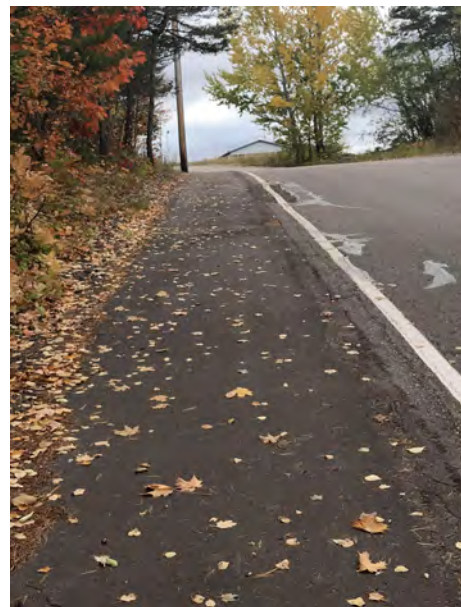
Pedestrian and driver views obstructed by the curve in the road. Nice, peaceful, enjoyable route.

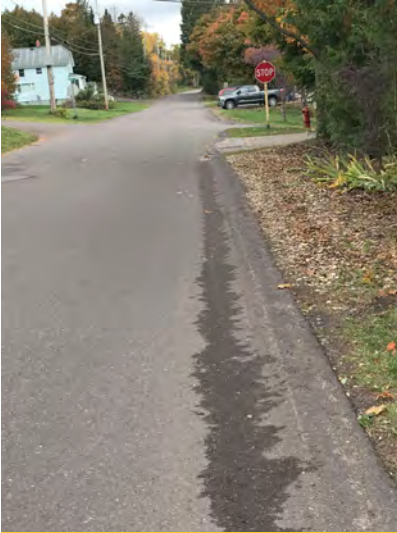
East 7th Ave. facing west

At intersection of E 7th Ave. and Portage St., drivers do not yield. Pedestrian and driver views are obstructed. Difficult to cross.

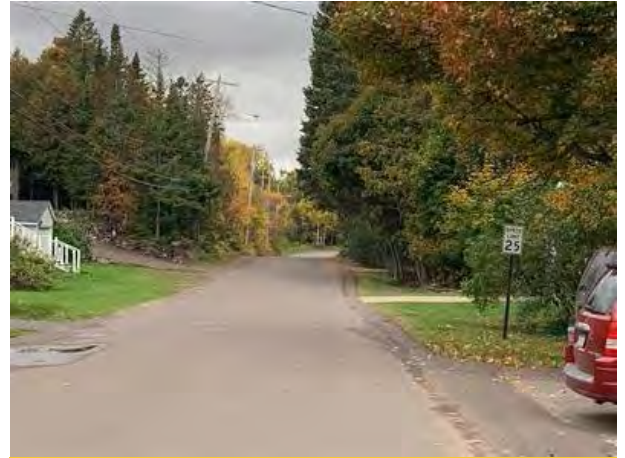
East 7th Ave. facing east

Road is flat and has high pedestrian and vehicular traffic. No sidewalks along entire road on either side of the street.

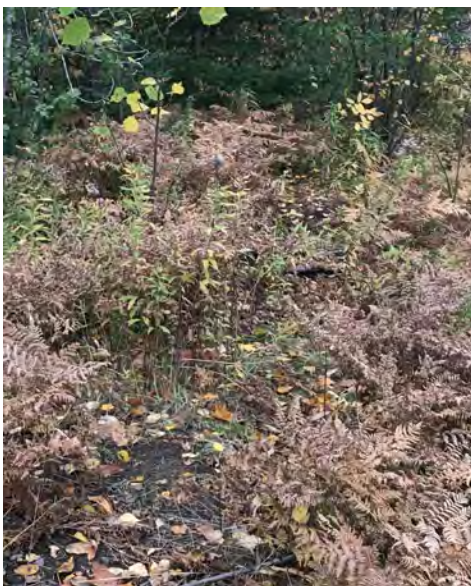
Champion St. facing south

Shortcut too narrow and has poor lighting. Path is treacherous during the winter. Potentially a good route if developed.

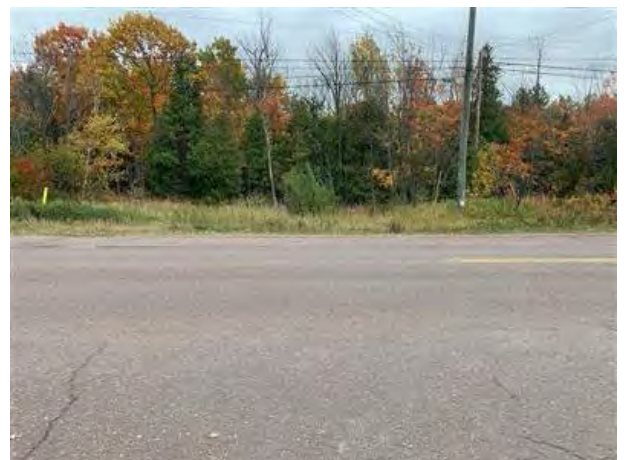
Sharon Ave. facing south

No pedestrian signal or crosswalk, driver's view obstructed and fast traffic. Difficult to cross Sharon Ave. when exiting informal route from Datolite St.

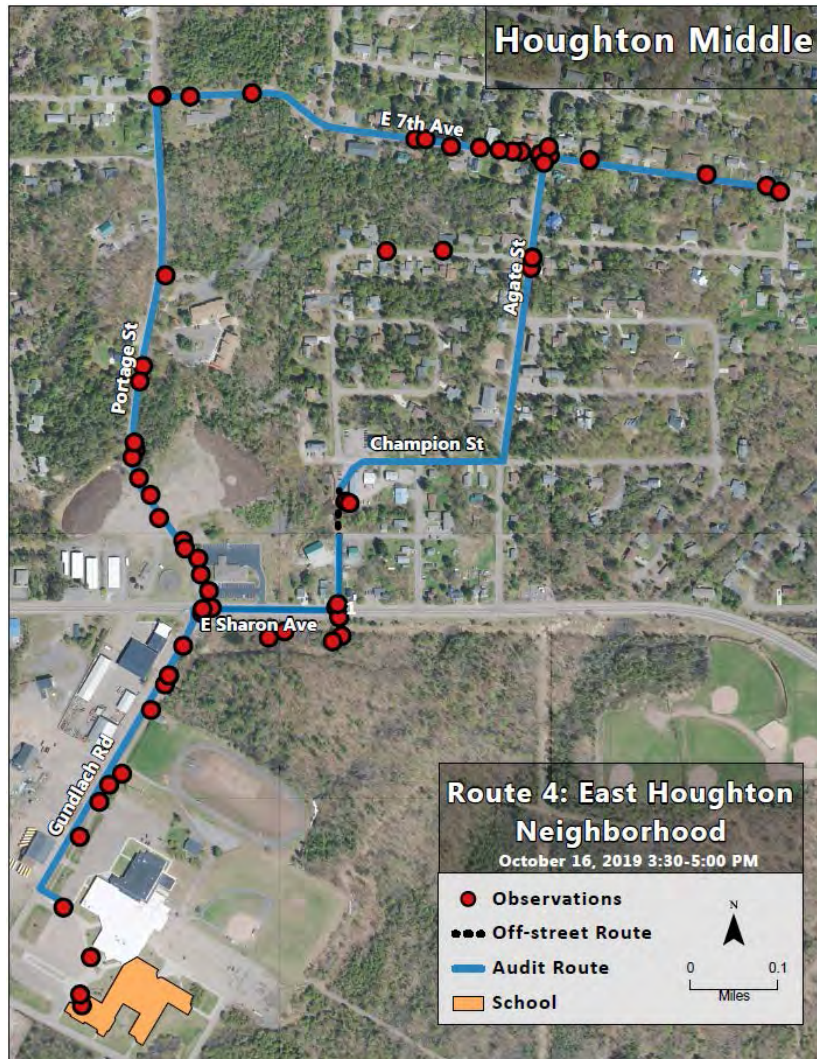
Route 4: East Houghton Neighborhood

Map of all observations

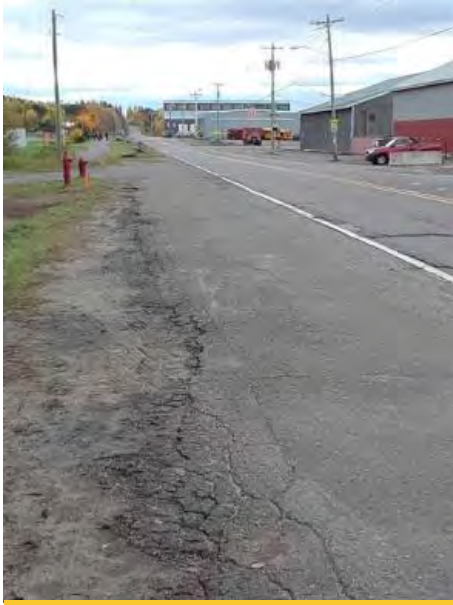
### Gundlach, facing northeast

Shoulder becomes unpaved near the intersection.

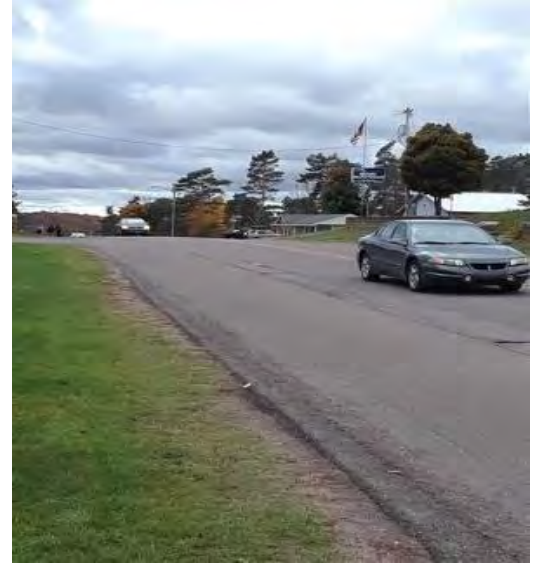
No separation of shoulder from the road. Cars are also moving faster than the speed limit.

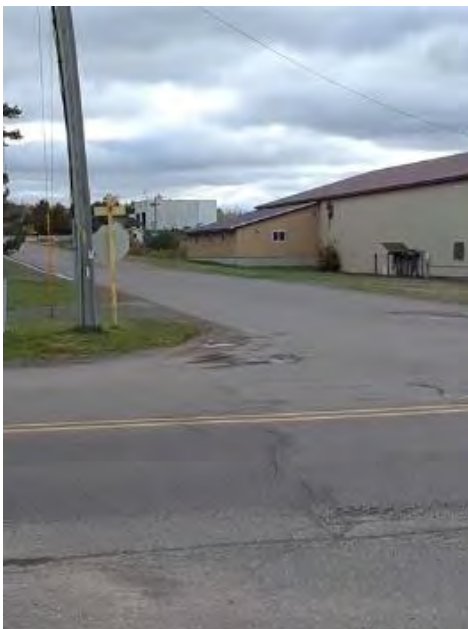
### Sharon, facing north

There is no pedestrian signal. Traffic volume is too high, and drivers do not yield.

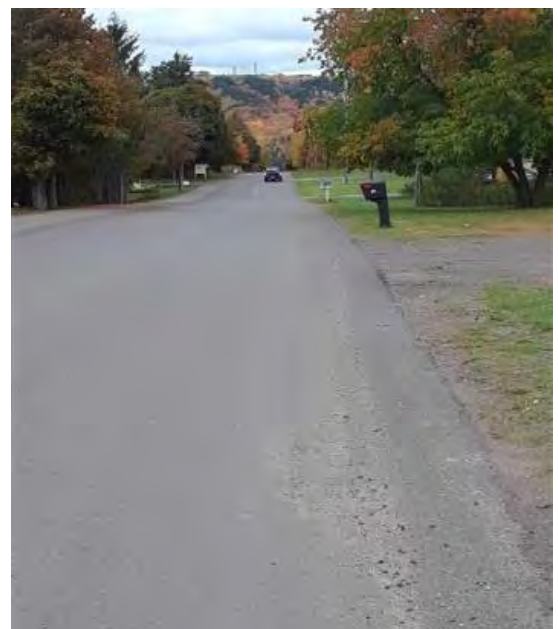
### Dodge, facing north

Road is too wide and there is no sidewalk or tree line.

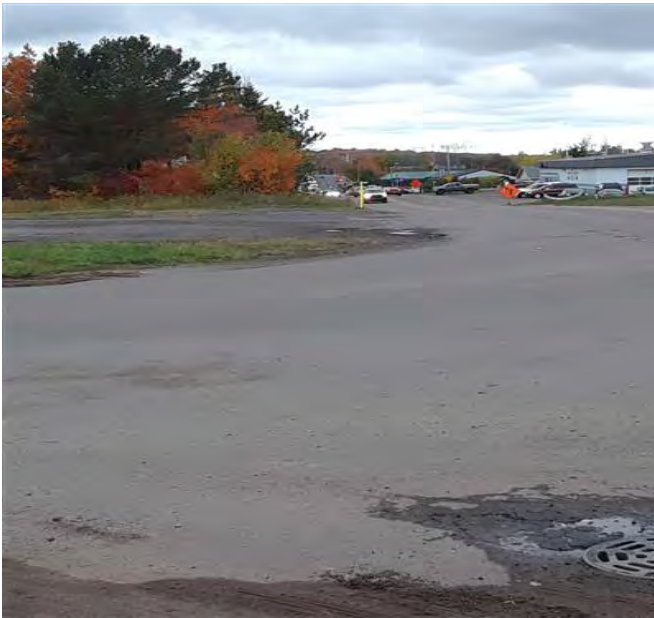
Sharon, facing south

There is no pedestrian signal and traffic volume is high.

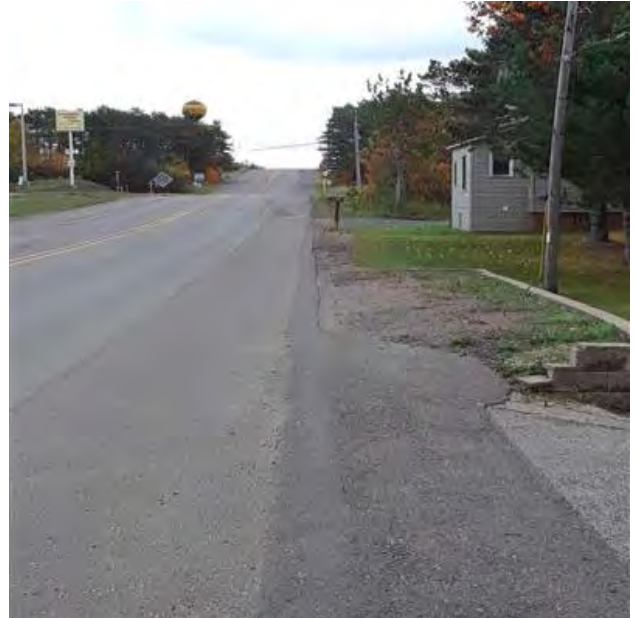
Sharon, facing east

No sidewalk or clearly paved trail.

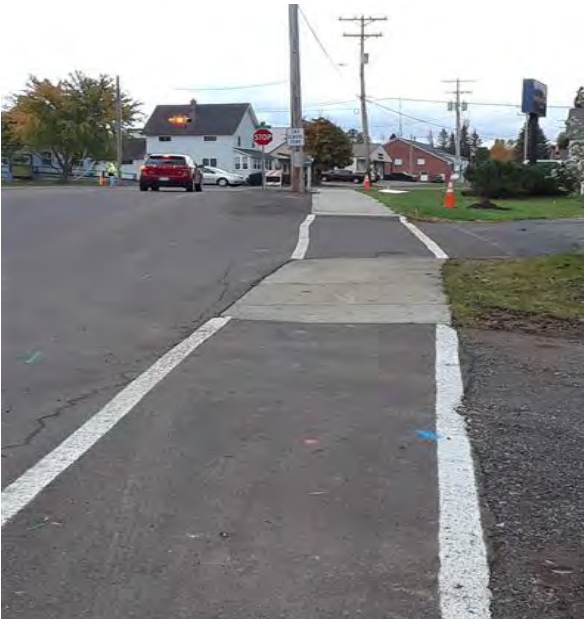
Military, facing south

Sidewalk and path is too narrow and extremely close to traffic.

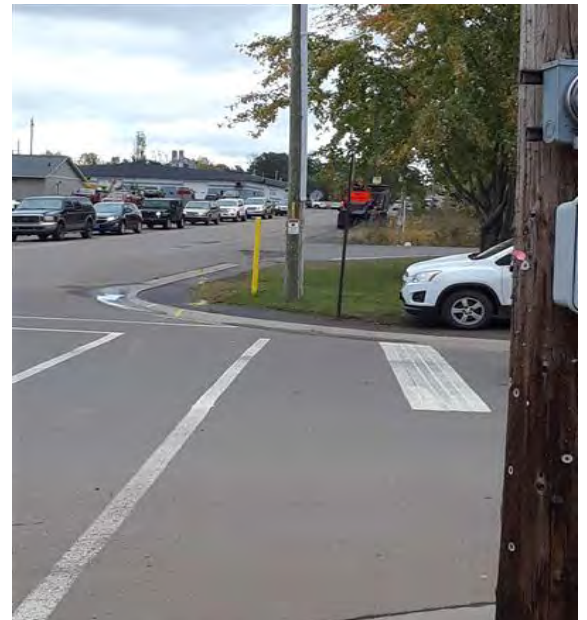
Sharon, facing east

There is no pedestrian signal and traffic volume is high.
