# Stamp Sand Threat to Buffalo Reef & Grand Traverse Bay: LiDAR/MSS Assessments Prior to "Trough" Dredging

## Executive Summary

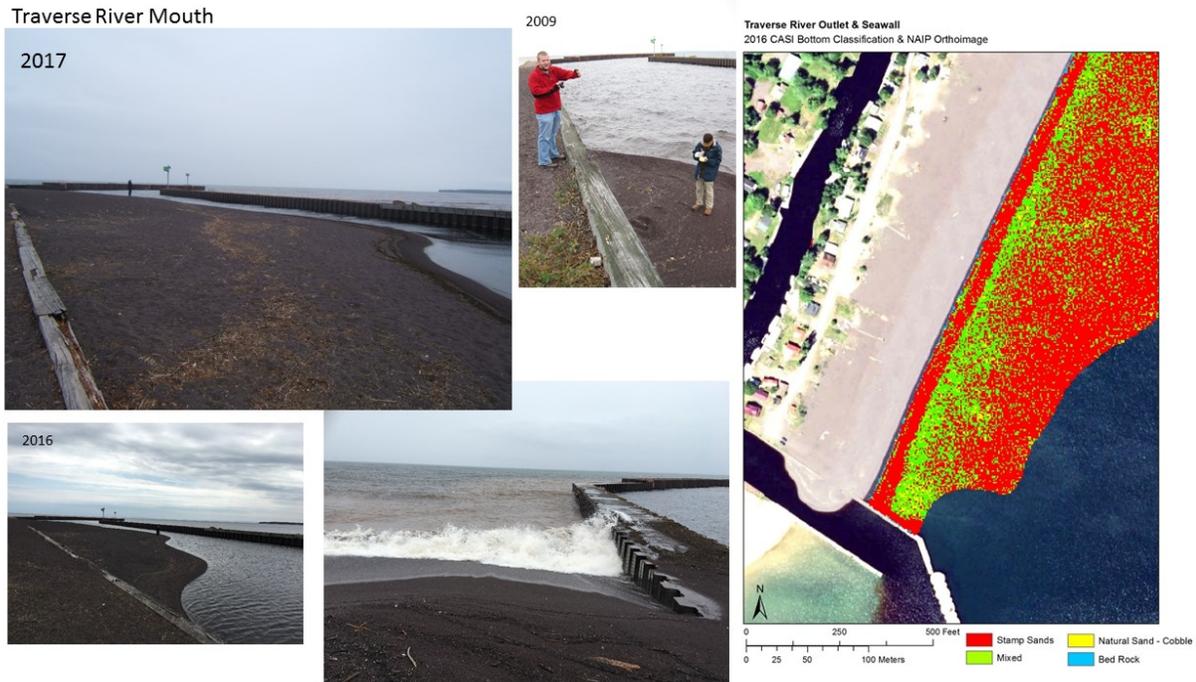
**Figure 19.** Airborne CASI image strip classification zoomed in the Traverse River mouth (right panel). The photos on the left of the figure show the overtopping progression from 2009 to 2017. The bottom type classification indicates the presence of significant stamp sands just offshore.

Using the aircraft classified bottom type map, a closer examination of the stamp sand migration near the Traverse River Harbor is possible. Figure 19 shows the classified bottom map (right panel) zoomed in to show the Traverse River mouth. Also shown on the figure are photographs labeled by year showing the dramatic increase in stamp sand overtopping of the seawall. The high resolution of the aircraft image confirms the almost 100% stamp sand cover just offshore of the Traverse River indicating the continued likelihood of overtopping to continue at a very high rate in the foreseeable future.

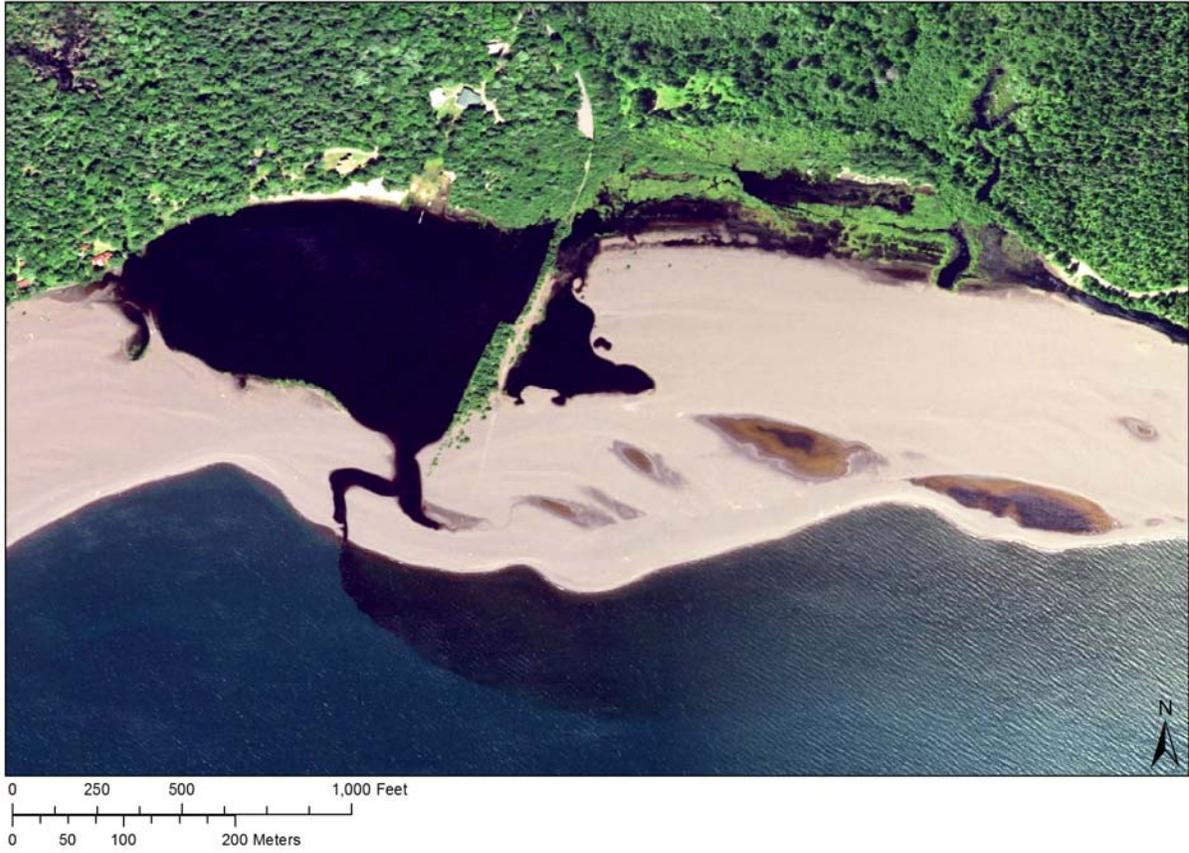
*Figure 30: 2016 NAIP Image of Coal Dock Pond. Note humic waters discharging into the bay.*

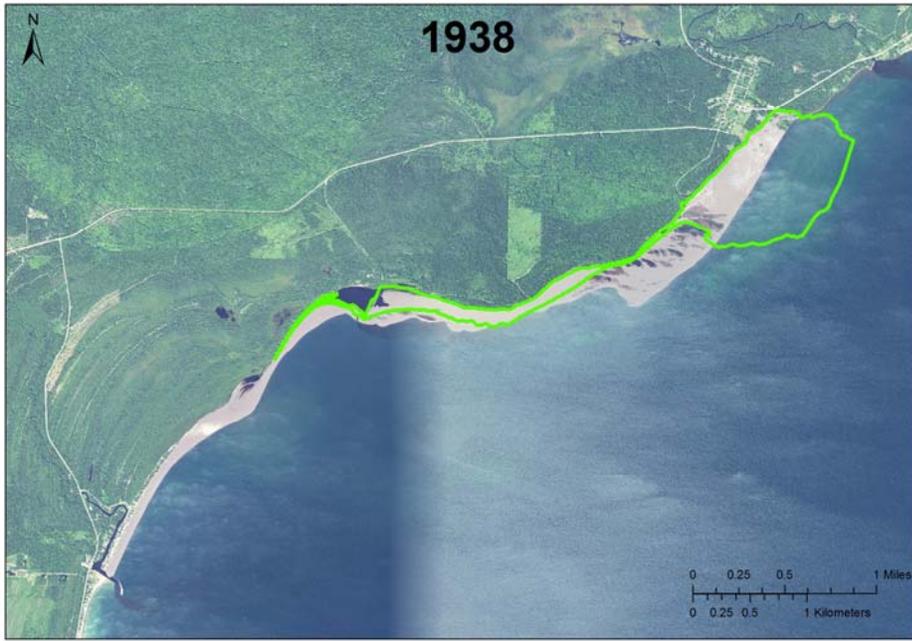
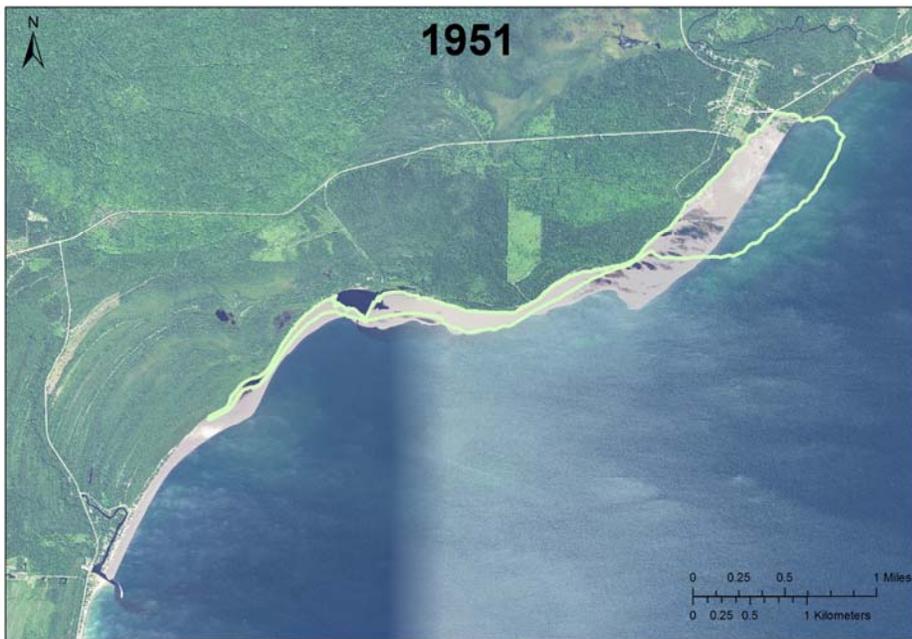
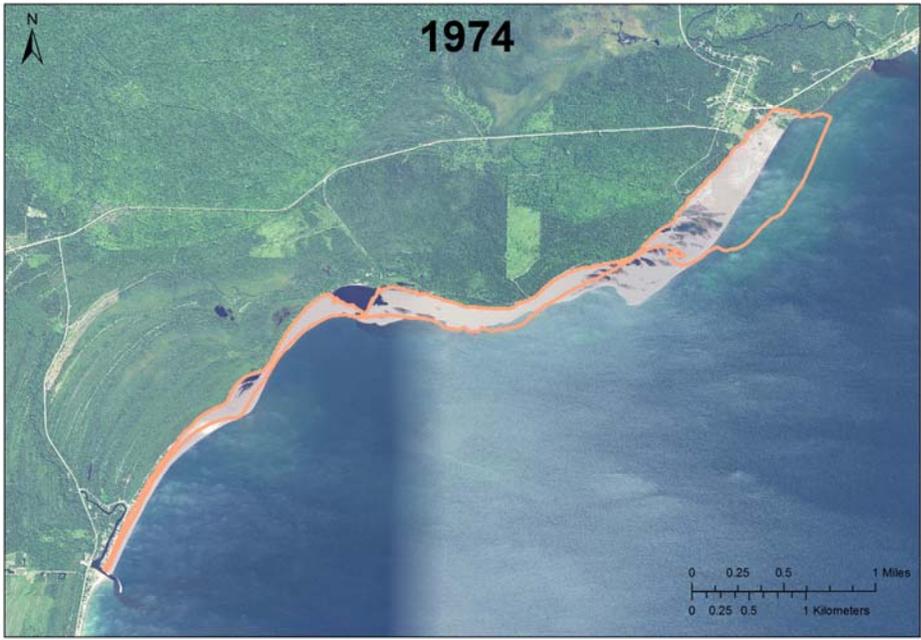
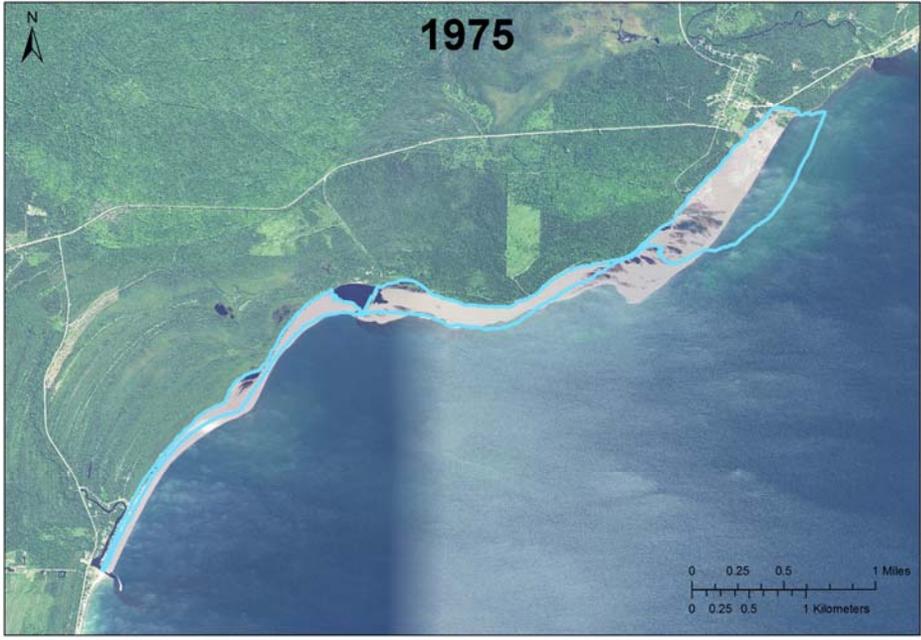
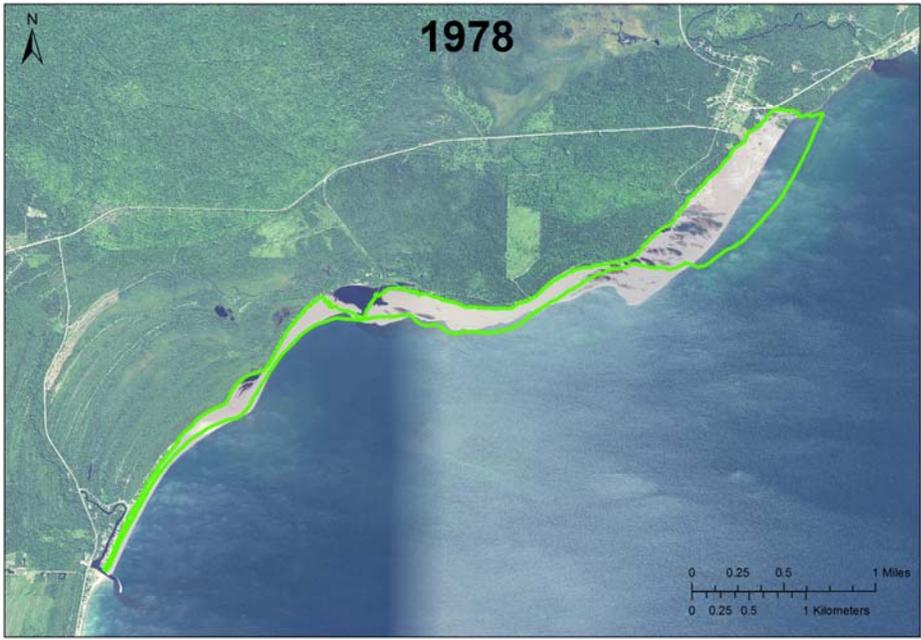
The following graphics show the changing extent of stamp sands from 1938-2016, drawn on top of a 2016 NAIP composite aerial image. The sources of the boundaries are historical imagery and recent Lidar.

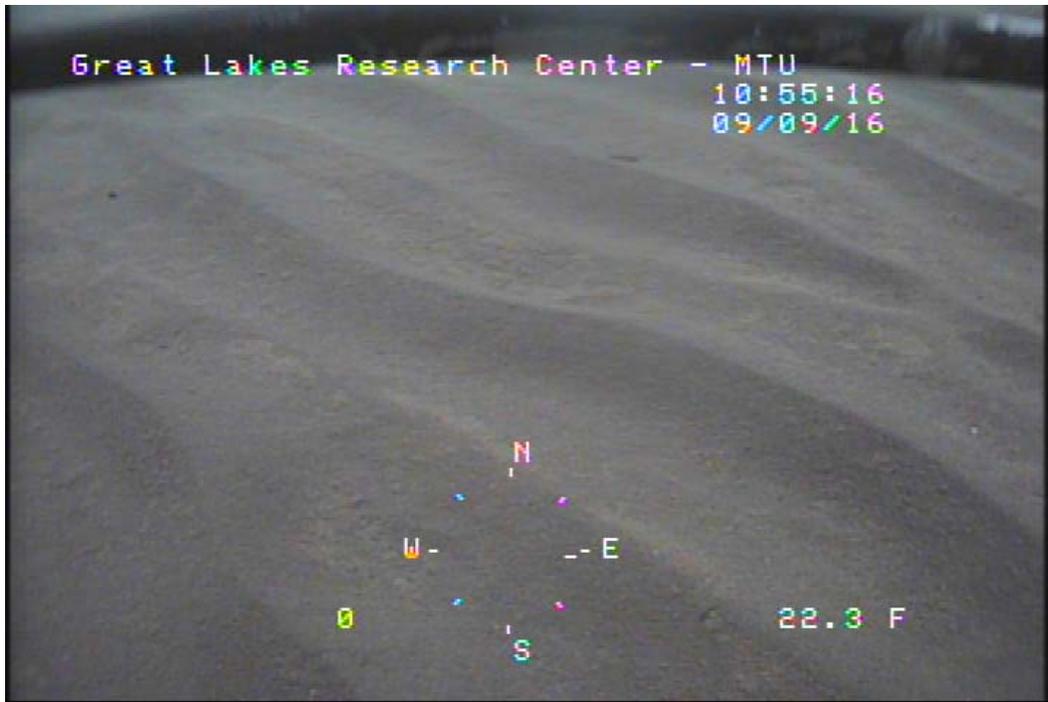
*Figure App-2-2: ROV survey location A (waypoint 2) – within trough*

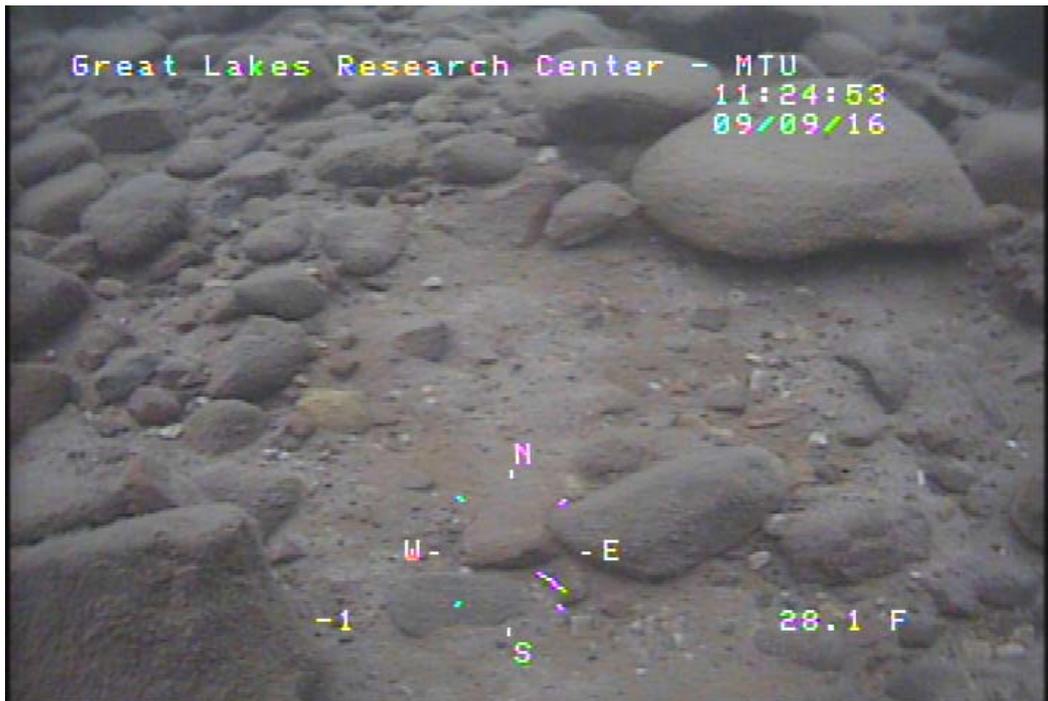
*Figure App-2-3: ROV survey location B (waypoint 5) – cobble area*

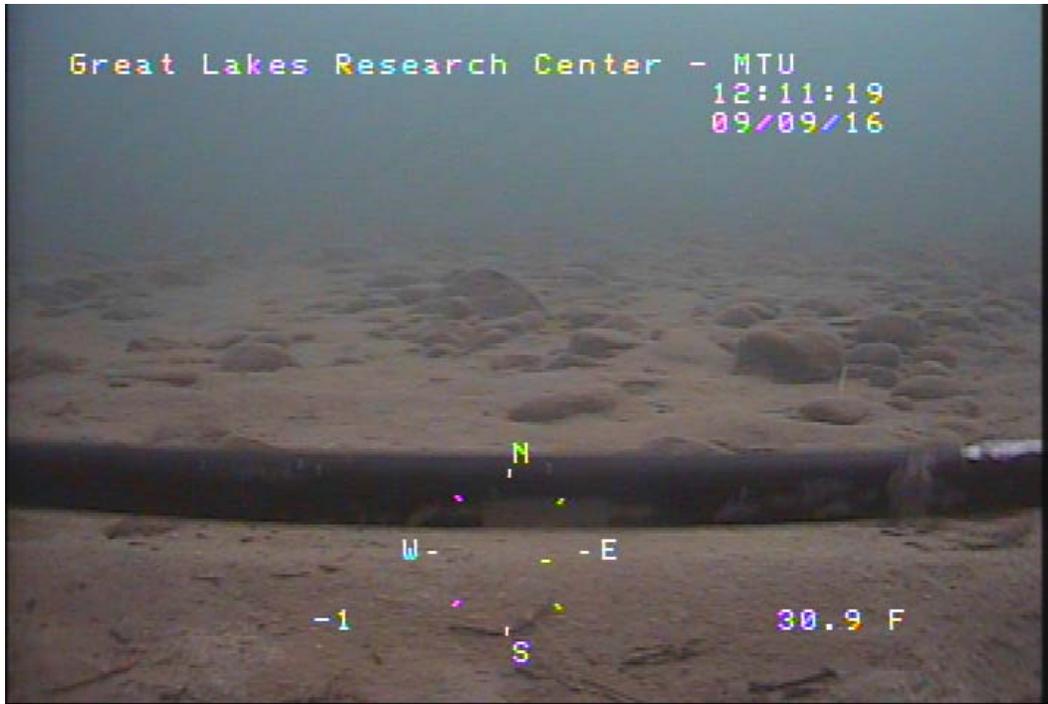
*Figure App-2-4: ROV survey location C (waypoint 8) – stamp sand / Buffalo Reef edge*

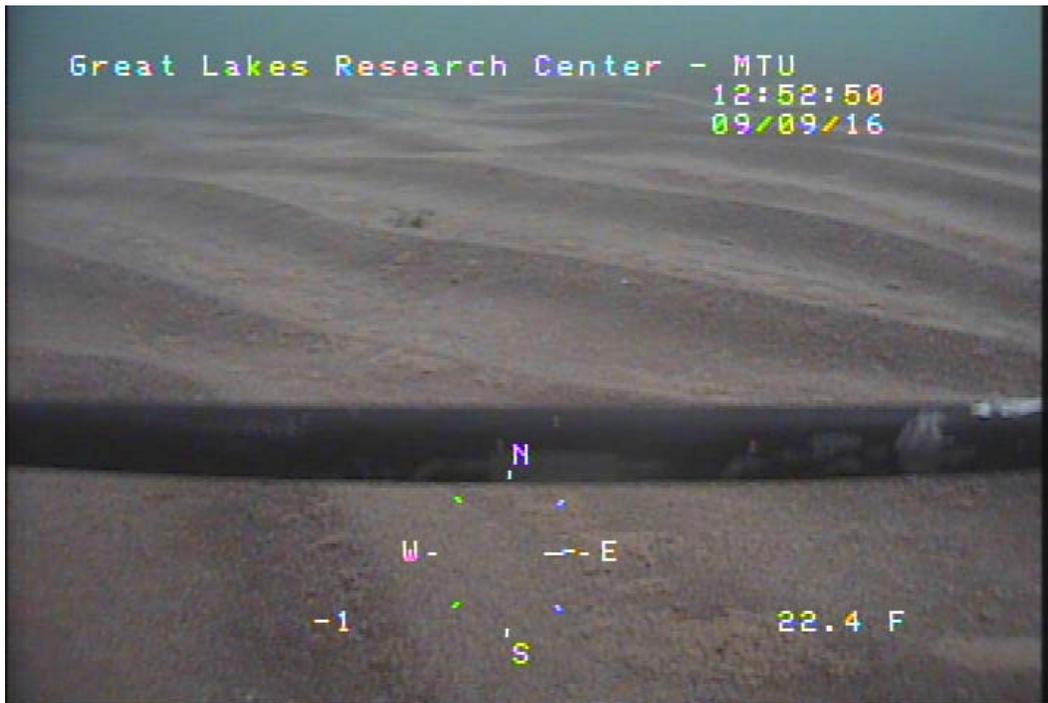
*Figure App-2-5: ROV survey location D (waypoint 11) – trough area*

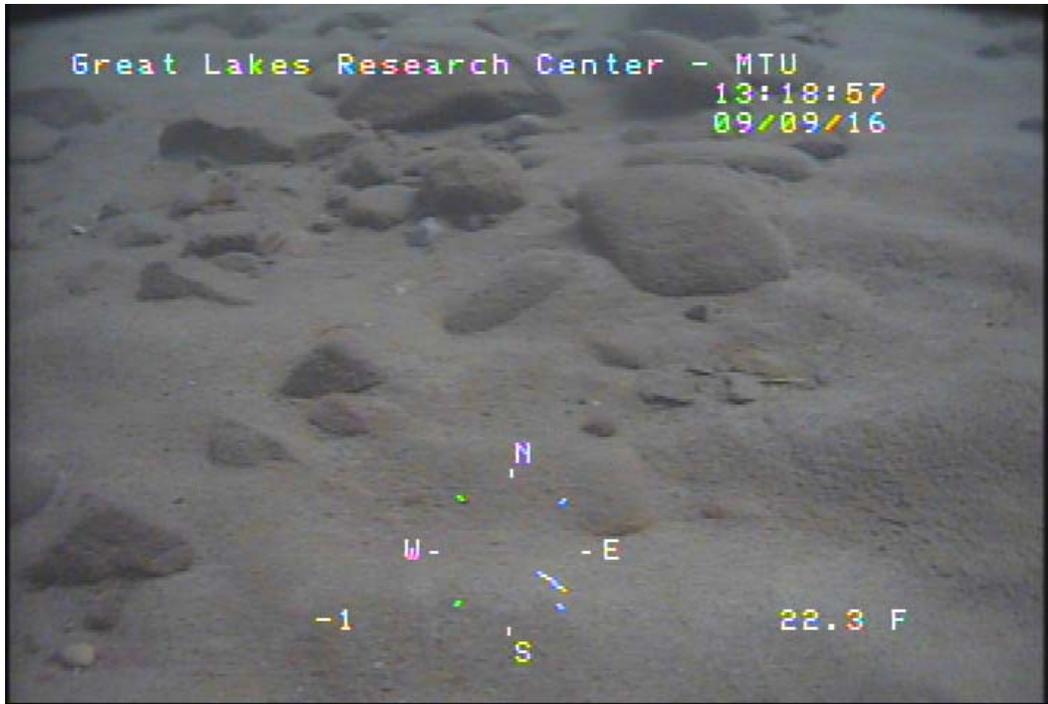
*Figure App-2-6: ROV survey location E (waypoint 13) – trough / Buffalo Reef edge*

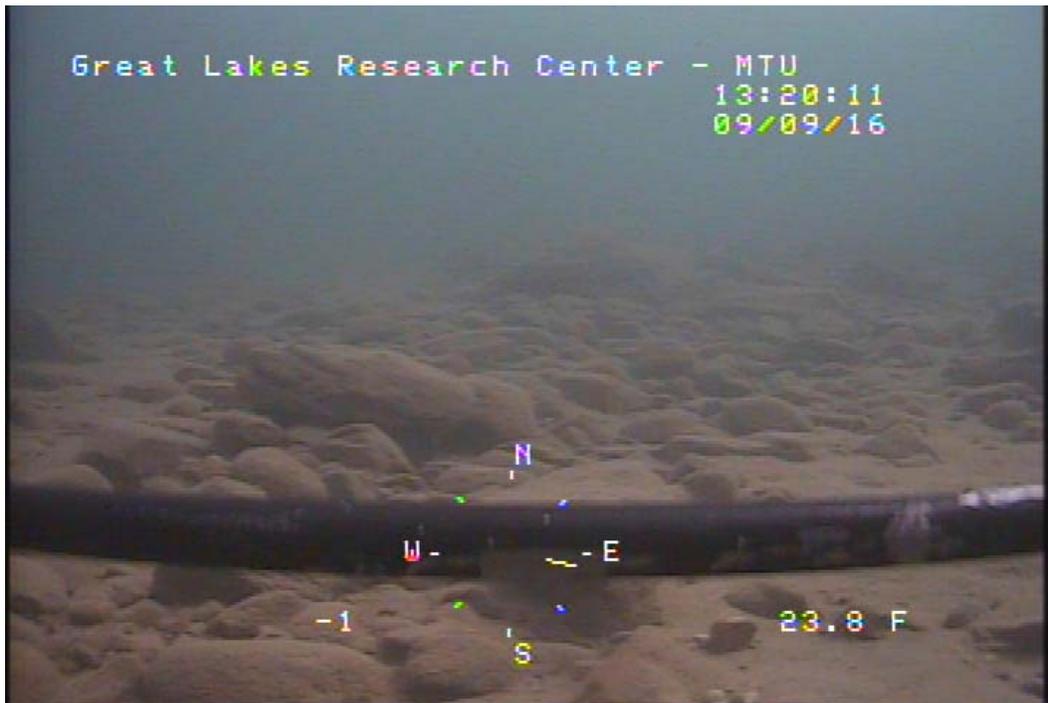
*Figure App-2-7: ROV survey location E (waypoint 14) – stamp sand encroached on Buffalo Reef*

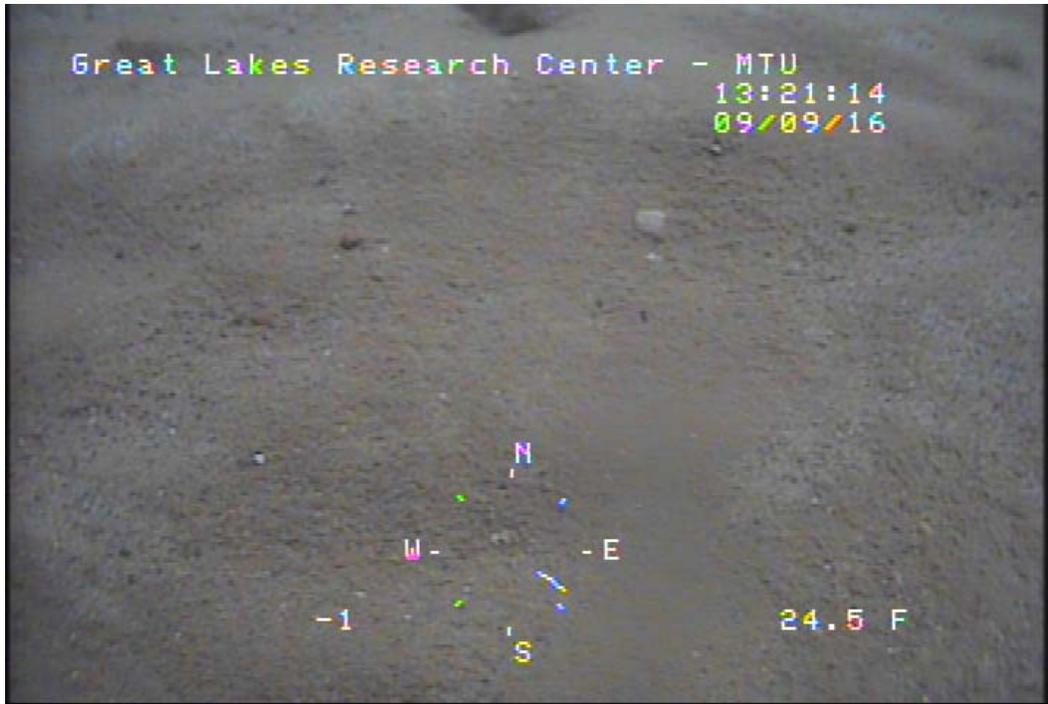
*Figure App-2-8: ROV survey location E (waypoint 15) – stamp sand encroached on Buffalo Reef*

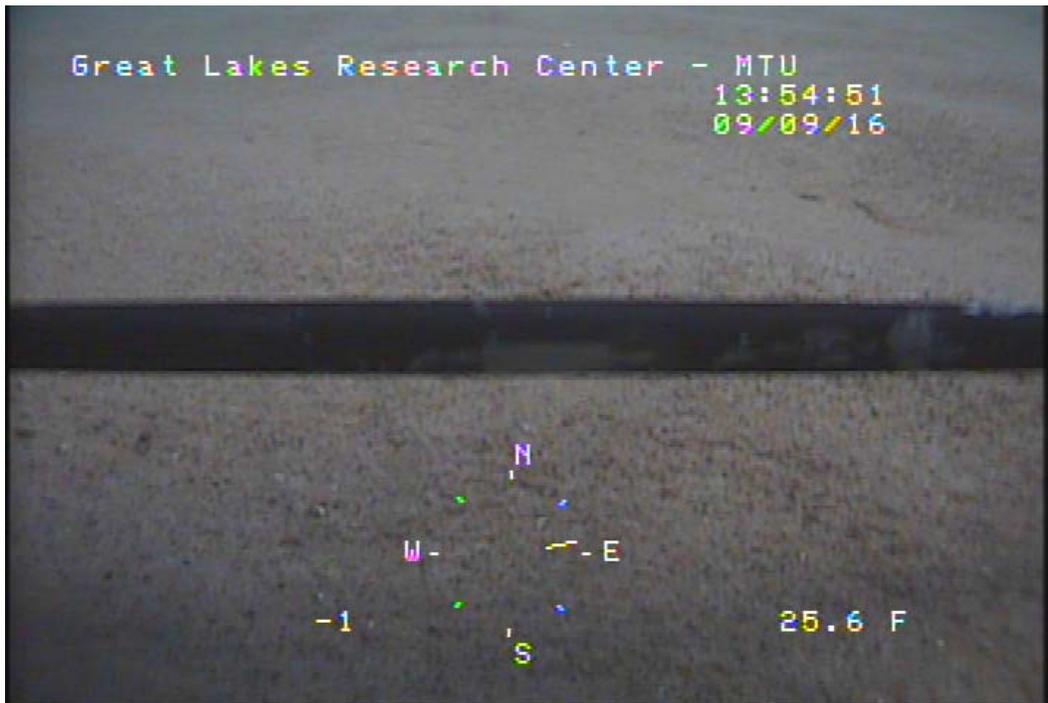
*Figure App-2-9: ROV survey location F (waypoint 16) – Stamp sand encroached on Buffalo Reef*

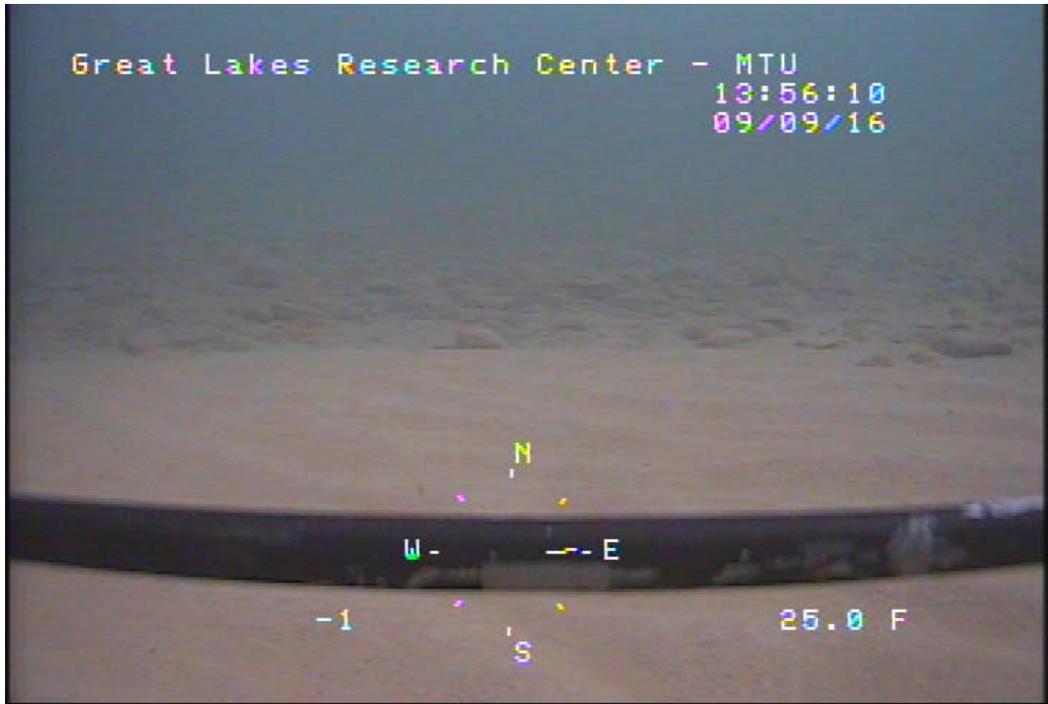
*Figure App-2-10: ROV survey location F (waypoint 17) – transition from stamp sand to Buffalo Reef cobble*

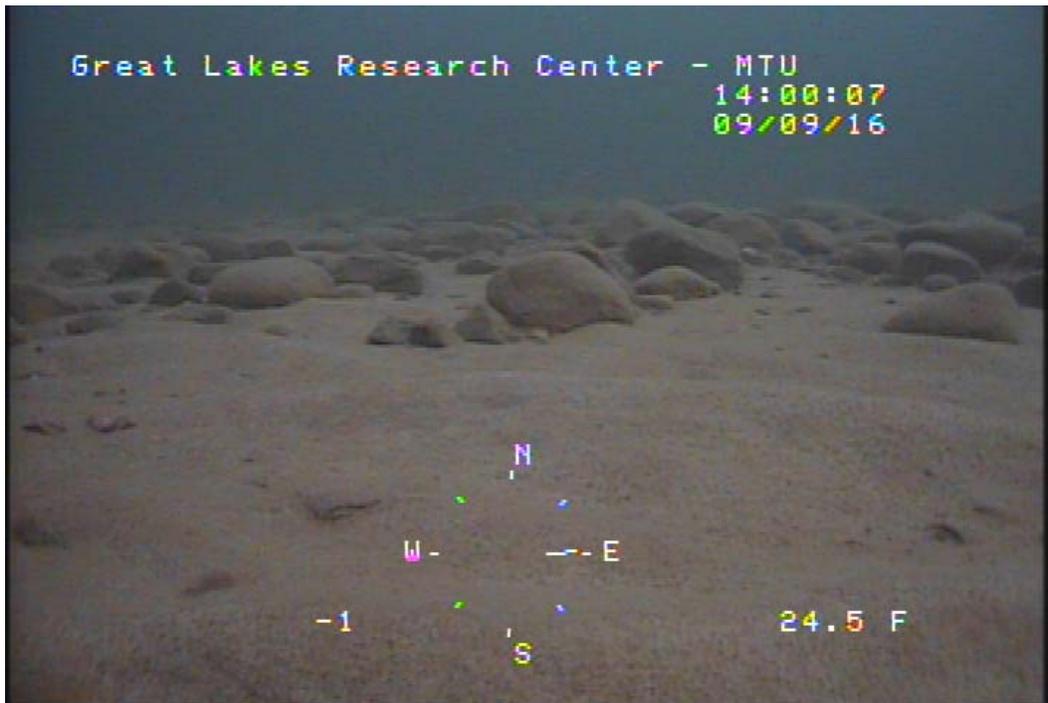
*Figure App-2-11: ROV survey location F (waypoint 18) – transition from stamp sand to Buffalo Reef cobble*

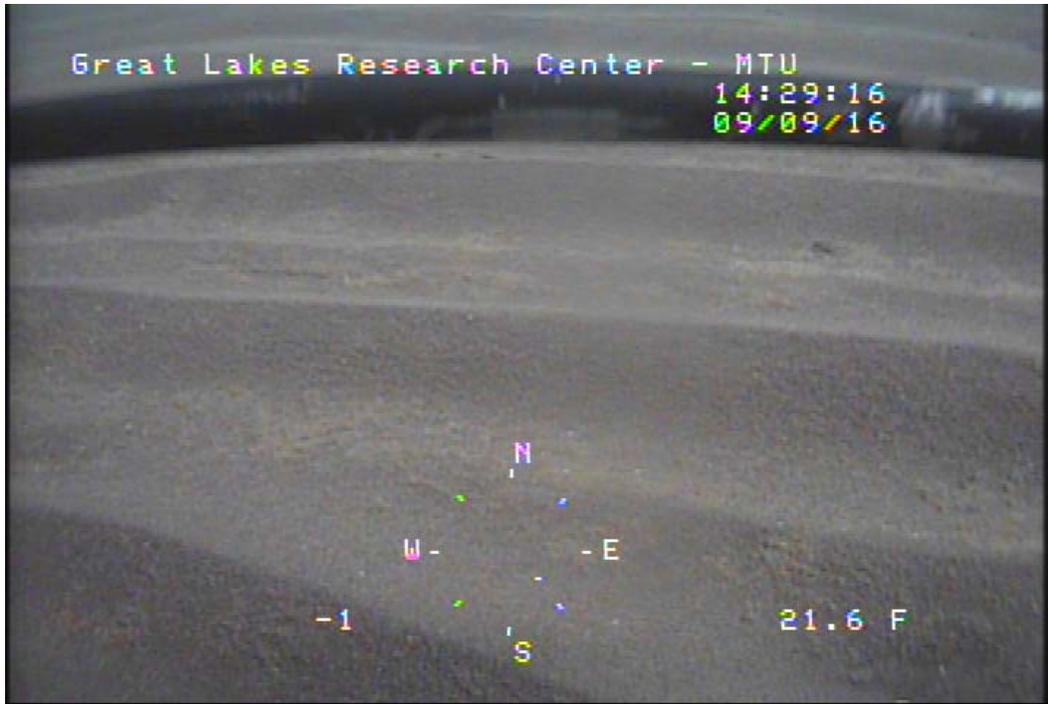
*Figure App-2-12: ROV survey location G (waypoint 20) – trough area*

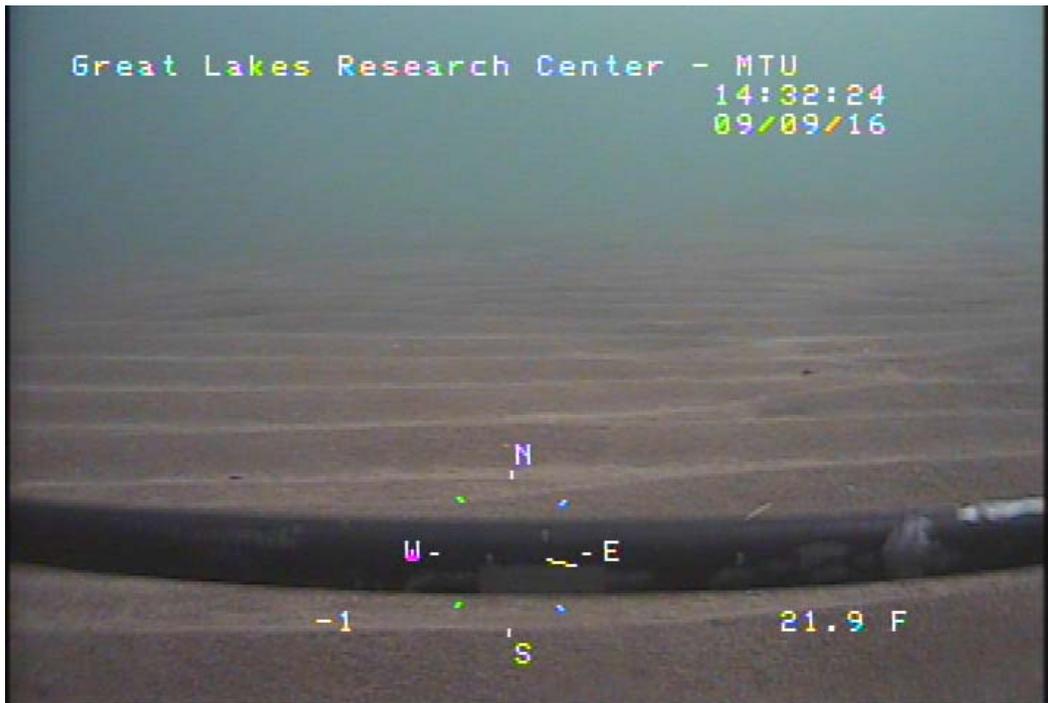
*Figure App-2-13: ROV survey location G (waypoint 21) – trough area*

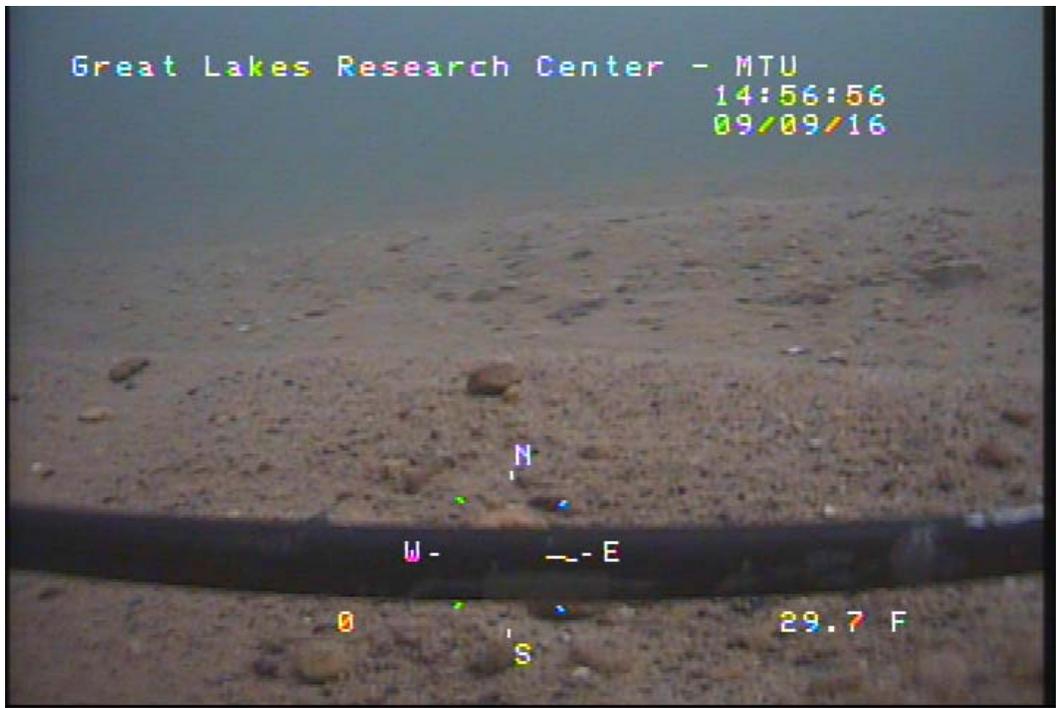
Figure App-2-14: ROV survey location H (waypoint 23) – edge of trough

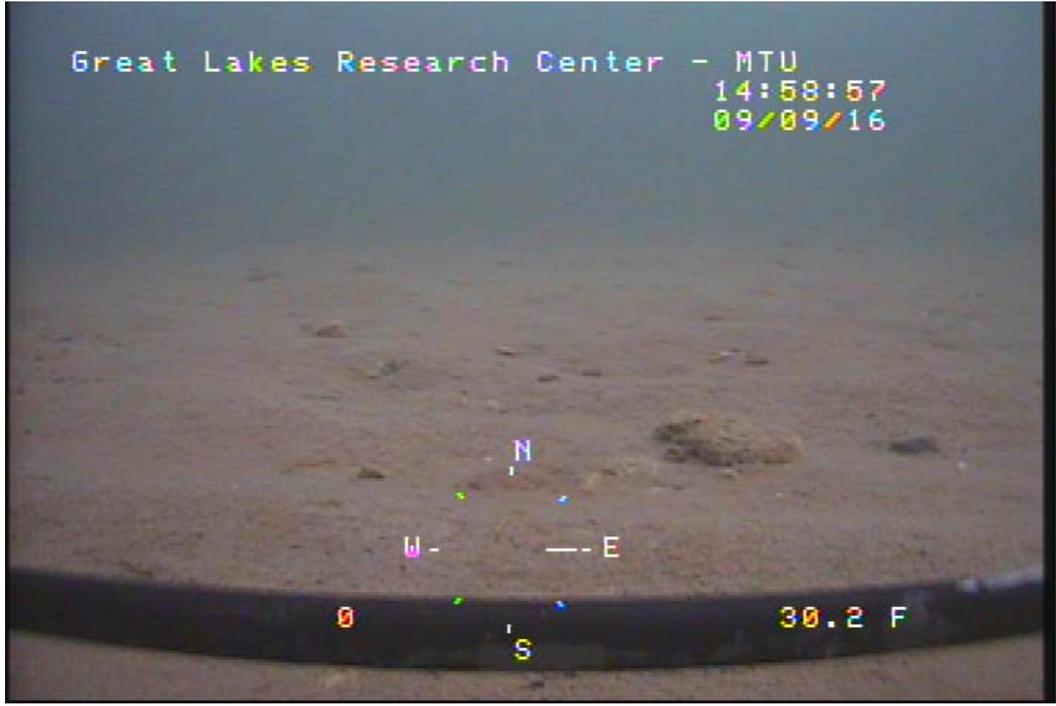
Figure App-2-15: ROV survey location H (waypoint 24) – edge of trough

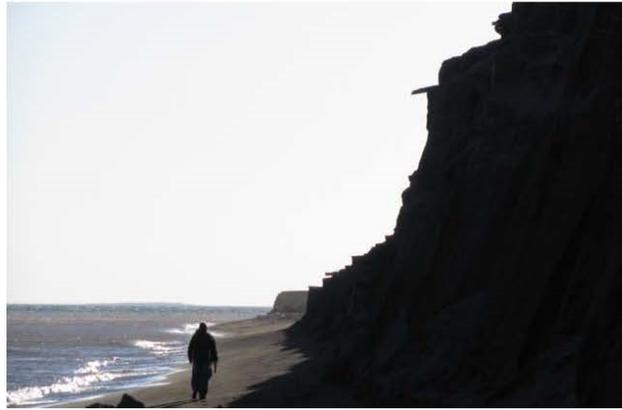
Figure 5a. Wave erosion of the Gay tailings pile. The near-vertical 7 m bluffs contain well-preserved remnants of wooden troughs that sluiced stamp sands across the pile.

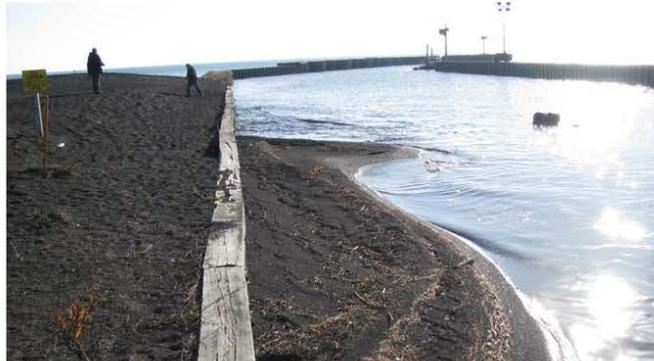
### SS Overtopping: Traverse River

- 1) have progressively moved along coastline,
- 2) dammed stream/river outlets & overtopping seawalls (Traverse River)
- 3) transgressed into coastal wetlands and threaten recreational beaches (southern white beach region)
- 4) suppressed coastal pond & benthic communities
- 5) threaten critical fish breeding grounds (Buffalo Reef) & whitefish rearing site (southern bay)

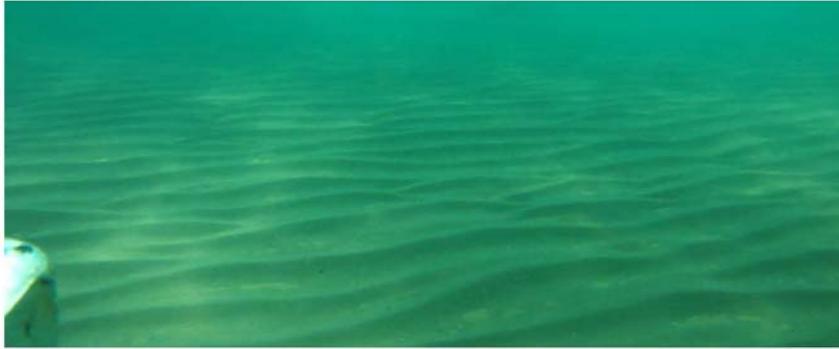
### Migrating Stamp Sand Field

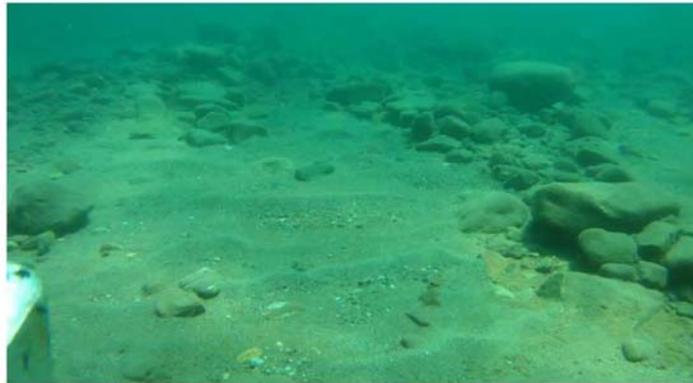
### Stamp Sand Encroachment

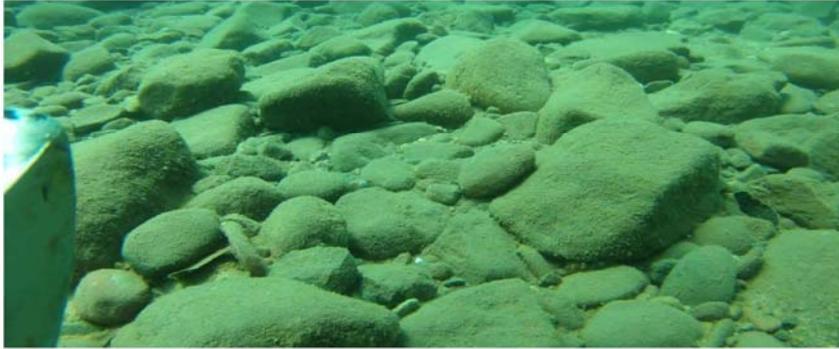
Buffalo Reef Cobble/Boulder Field

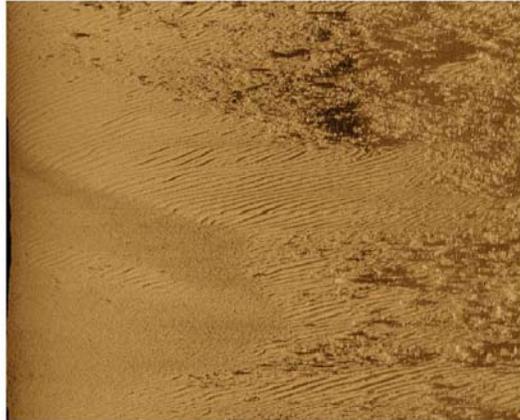
Hi-Res Side-scan Sonar (R/V Storm): Stamp Sands Moving Into Boulder Field

Stamp sands are moving into the northern boulder fields of Buffalo Reef. Migrating bars of stamp sands are moving across bedrock, spilling into and filling the northern “trough” region, an ancient riverbed cut across the Jacobsville Sandstone coastal shelf. As stamp sands mound up in the northern “trough”, they begin to move westward into Buffalo Reef boulder fields. Dredging of “trough” sediments is recommended as a practical solution to slow encroachment of stamp sands into the northern boulder fields of Buffalo Reef, and dredging of the Traverse River is recommended as a means of temporarily alleviating Seawall overtopping and navigation impediments.
